# Technical Bulletin

Bulletin No: TCH-013-024

**Subject: Bendix® TABS-6™ Advanced Single-Channel Trailer ABS: Troubleshooting  
“Internal Lateral Acceleration Sensor - Mounting Error” Diagnostic Trouble Codes**

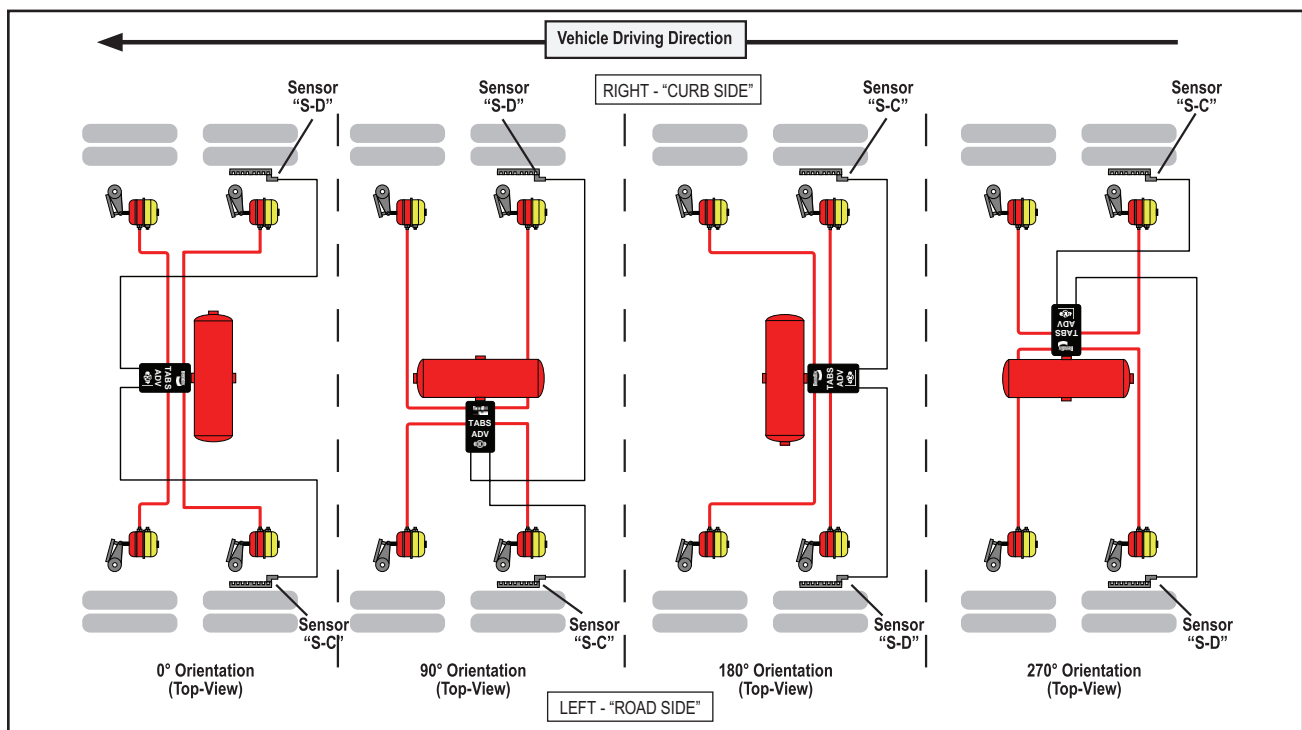
FIGURE 1 - BENDIX® TABS-6™ ADV MODULE ORIENTATION & WHEEL SPEED SENSOR LOCATIONS

This DTC is caused by the ECU comparing the difference in wheel speed readings between the left and right wheel speed sensors to cross-check with the on-board lateral accelerometer. Reversed sensors can cause a DTC to falsely trigger. Wheel speed sensors ‘SC’ and ‘SD’ locations are ECU-orientation specific (See Figure 1).

Each Bendix TABS-6 Advanced ECU comes preconfigured for a certain orientation. Use the Bendix® ACom® Diagnostics software [free software downloads are available at [www.bendix.com](http://www.bendix.com)] to view the current configured orientation of the ECU on the Controller Configuration screen. Then use Figure 1 below to verify if the TABS-6 Advanced ECU is installed as configured.

- change the configured orientation to match the installation;
- verify that the speed sensors are installed correctly for this configured orientation (see Figure 1); and
- perform an End-of-Line Test (EOL Test) using the software or a Bendix® Trailer Information Module™.

Make any needed changes, and then use the Bendix® ACom® Diagnostics software to run the Bendix® TABS-6™ Advanced End-of-Line Test (EOL Test) and recheck for any other remaining DTCs before returning the vehicle to service.
