## Charging System Voltage VN, VHD

### FSB 322-001, Charging System Voltage

(November 2013)

On vehicles equipped with a Volvo Engine built from January 1, 2010 to June 28, 2013 with the left front battery box location (not the stacked battery box or Dometic system equipped vehicles), the voltage drop on the charging circuit may be higher than is recommended when utilizing the voltage drop test with the Intellicheck tester. The voltage drop is acceptable to charge the batteries but the test using the Intellicheck tester may show failed or under specification.

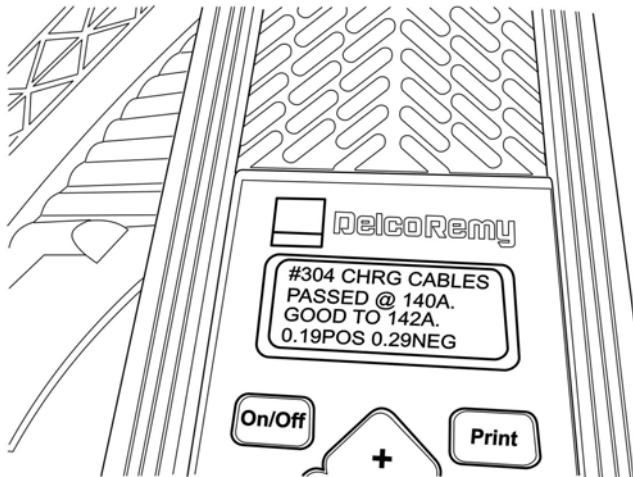
W3083778

- Clean and tighten all power connections on the alternator, batteries and cables.
- Repeat the test with the Intellicheck tester and record the voltage drop reading for positive and negative.
- Add the two readings: **If the total is 0.60 V or less then the voltage drop is acceptable** no further action is needed.

If the total is greater than 0.60 V then perform the following procedure:

Sample calculation  $A + B = \leq 0.60 \text{ V}$

Example:  $0.19 + 0.29 = 0.48$  (**Passed**) No further action required.
