## **SB-10054054-4887**

### **FSB 373-018, Transmission Connector (Multiple Open Circuits)**

(November 2013)

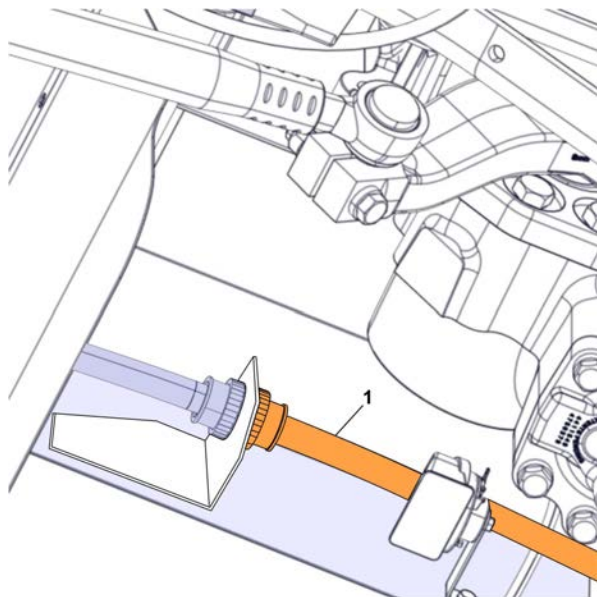
W3085373

On some Mack models built with an Allison transmission, between May 16, 2011 and August 9, 2013, may experience multiple open circuits in the 31 way transmission connector. This is due to a supplier manufacturing issue with the connector. If this issue is found follow the procedure below:

1. Approximate location of "Yellow" marking

4. Look for yellow marking on harness (1).
  - a. If marking is present then no further action required. (Lower the cab).
  - b. If **NO** marking present, see repair below.

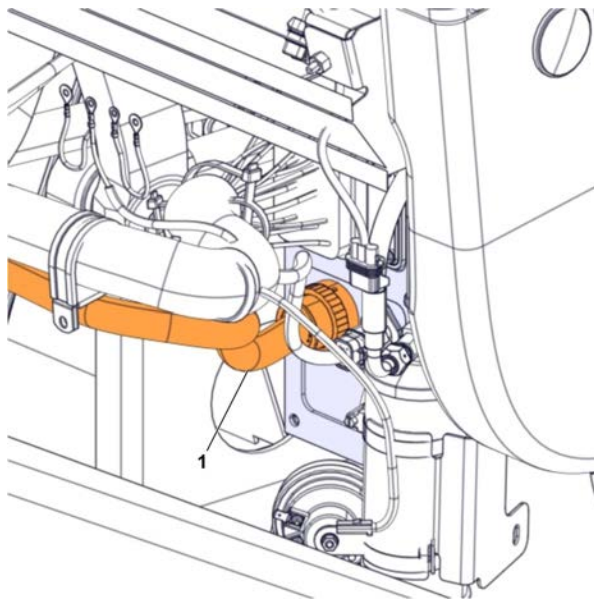
W3085374

1. Approximate location of "Yellow" marking
3. Inspect harness for "Yellow" marking on harness (1).
  - a. If marking is present then no further action required.
  - b. If **NO** marking is present, see repair below.
