## **SB-10054057-9351**

Transmission Connector (Multiple Open Circuits)  
CHU, CXU, GU, TD

### **FSB 373-019, Transmission Connector (Multiple Open Circuits)**

(November 2013)

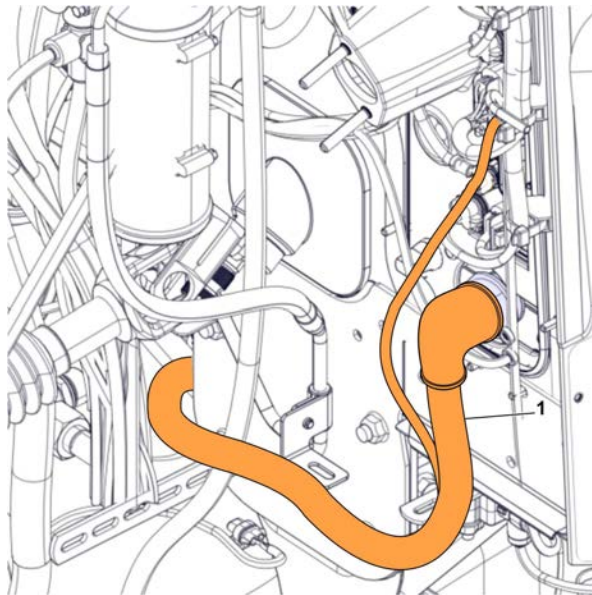
W3085839

1. Secure the vehicle for service by parking it on a flat level surface, applying the parking brake, chocking the rear wheel, and placing the transmission in neutral.
2. Raise the hood.
3. Inspect harness for "Yellow" marking on harness.
  - a. If mark is present then no further action required. (Close the hood).
  - b. If **NO** mark present: see repair below.

1. Approximate location of "Yellow" marking

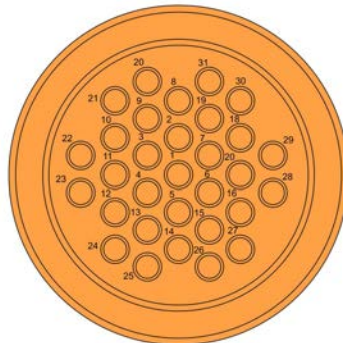
W3084149

Male Pin

- 3 Remove the transmission connector. Remove the cab side connector nut from the mount and pull connector out.
  - 4 Remove the elbow backshell from the transmission connector.
- 5 Remove the tape from the harness approximately 152 mm (6 in.) back from the connector.
  - 6 Extract the terminals from the Delphi connector one terminal at a time and insert it into the same cavity of the Deutsch connector.

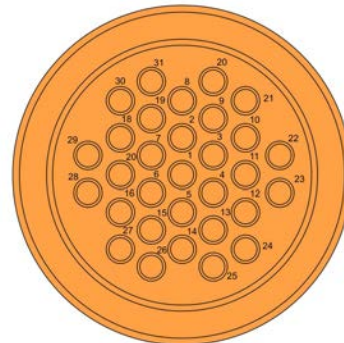
W3084150

Female Socket
