**Mack Trucks, Inc.**  
Greensboro, NC USA

# Service Program Trucks

**SB-10054060-4103**

## PI0834, Turbocharger Outlet Flex Pipe

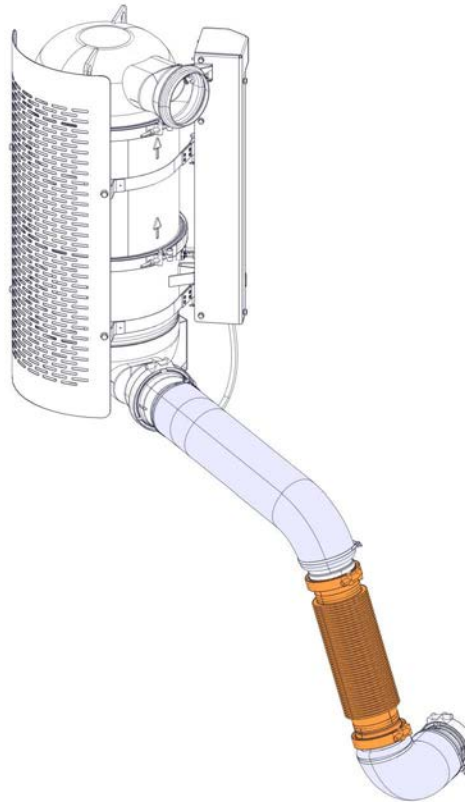
W2085297

Due to a durability issue with the turbocharger outlet flex pipe, it has been decided to replace the flex pipe on all Mack LEU and MRU vehicles with a MP7 or MP8 engine built between April 1, 2013 and October 13, 2013. Replace flex pipe part number 21959391 with flex pipe part number 21428530.

**Note:** To obtain the optimum life from the pipe, it should be installed straight.

**Note:** Flex pipe **MUST** be installed as straight and parallel to the turbocharger outlet pipe and DPF inlet pipe as possible.

**Note:** Flex pipe should NOT be installed in a curved manor.
