Wire Seal for Exposed Splice MRU

PI0825, Wire Seal for Exposed Splice

(October 2013)

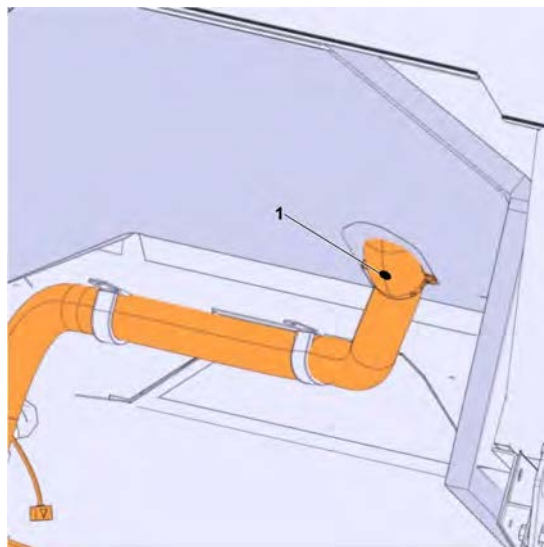
W3083653

- A. If word "OK" is present on the snorkel, then no further action is required.
- B. If word "OK" is **Not** on the snorkel, then proceed with repair procedure below.

1. Location of word "OK"

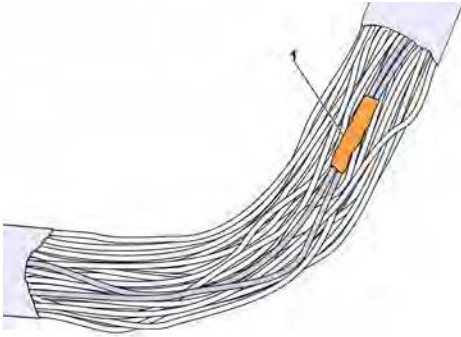
W3083457

10 Separate the wires and locate the (1) splice SPF38A.

Note: The splice is located 150mm (6 in) from the pass through.
