Front Spring Breakage
VAH**SP 721-005, Front Spring Breakage**

(October 2013)

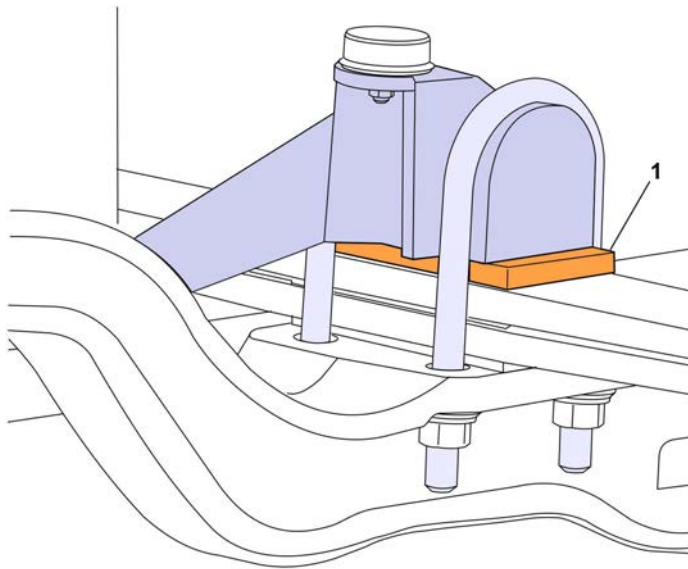
W7084034

It has been discovered on some VAH vehicles that the front springs can over travel. Over time this can lead to breakage of the spring leaf. A spacer plate will be installed to increase the height of the suspension bumpstops to limit spring travel.

- 1 Spacer to be added between top plate and leaf spring.
 - 7 Remove the top plate over the spring assembly.
 - 8 Install the new spacer onto the spring assembly.
 - 9 Install the top plate, new U-bolts and nuts and secure. Torque to 550 ± 25 Nm (406 ± 18 ft-lb).
- Note:** Tighten evenly in an X - pattern.
- 10 Install the lower shock mounting fastener. Torque to 415 ± 40 Nm (306 ± 30 ft-lb).
 - 11 Perform these same steps on the other side of the vehicle.
 - 12 Jack the steer axle up and remove jack stands and let axle down.
 - 13 Remove wheel chocks.
 - 14 Lower hood.
