## Technical Service Bulletin

<b>Topic</b>	Seat Belt Presenter - Intermittent Operation
<b>Market area</b>	Worldwide Bentley (1WBE)
<b>Brand</b>	Bentley
<b>Transaction No.</b>	2034323/3
<b>Level</b>	EH
<b>Status</b>	Released for publishing
<b>Release date</b>	Sep 12, 2013

Front seat belt system presenter intermittent in operation

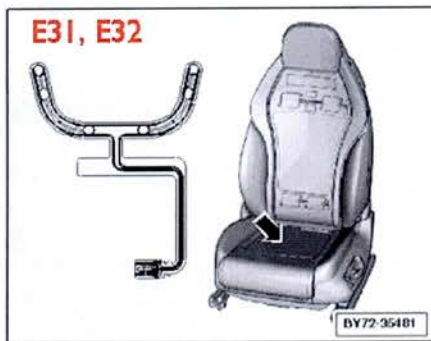
Figure 1

3. First check the occupancy sensor, E31, is function correctly (see Figure 1)

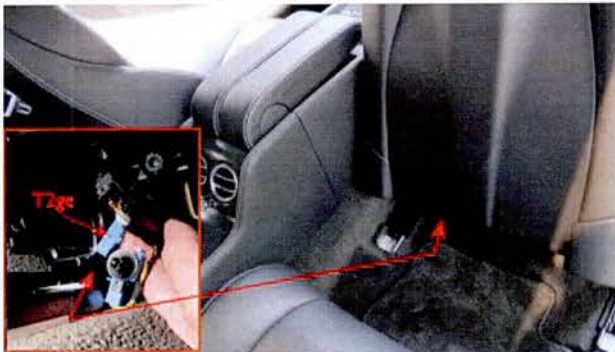
Figure 2

- Disconnect connector T2ge at the occupancy sensor (E31 Drivers, E32 Passengers). The 2 way connection can be identified by its blue connector housing located under the seat frame adjacent to the inboard seat runner (see Figure 2)

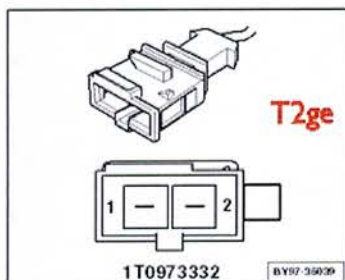
Figure 3

- With T2ge connector disconnected and an occupant sat in a natural position on the seat, with their back against the backrest, measure the resistance through the occupancy sensor (see Figure 3)
