<b>HYUNDAI</b>   NEW THINKING. NEW POSSIBILITIES.  <b>Technical Service Bulletin</b>	GROUP	NUMBER
	<b>AUTOMATIC TRANSMISSION</b>	<b>12-AT-022-1</b>
	DATE	MODEL
	<b>OCTOBER 2012</b>	Tucson (LM), Santa Fe (CM), Sonata (YF), Elantra (UD/MD/GD/JK), Accent (RB), Azera (TG/HG), Veloster Turbo
SUBJECT:	<b>AUTOMATIC TRANSAXLE (6-SPEED)</b> <b>INHIBITOR SWITCH DTC P0705, P0706, P0707 &amp; P0708</b>

*This TSB supersedes 12-AT-022 to revise the Parts Information*

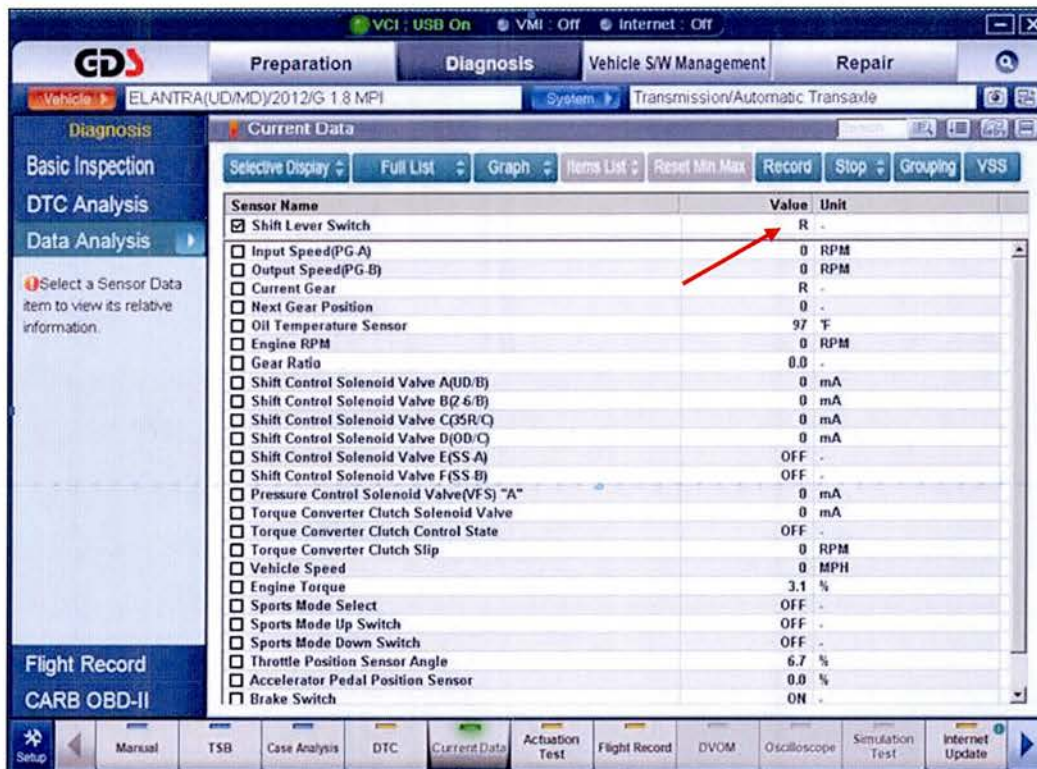
1. Turn the ignition key to the ON position or push the Start/Stop Button two times.
2. Using a GDS, check for DTC in the "Automatic Transaxle" menu. **Record the DTC and description.** Delete the DTC.
3. Select the following parameters. Move the shift lever through all gears and monitor the sensors.
  - Vehicle and A/T menu.
  - "Current Data"
  - Shift Lever Switch.
