GROUP Fuel System	MODEL 2011-2013MY Optima w/2.0L & 2.4L GDI (QF/TF) 2011-2013MY Sportage w/2.0L GDI (SL) 2012-2014MY Sorento w/2.4 GDI (XM) 2014MY Sorento w/3.3L GDI (XM) 2014MY Cadenza w/3.3L GDI (VG)
	NUMBER 026	DATE September 2013

TECHNICAL SERVICE BULLETIN

SUBJECT: MIL ON WITH DTC P0087 - DIAGNOSIS AND REPAIR

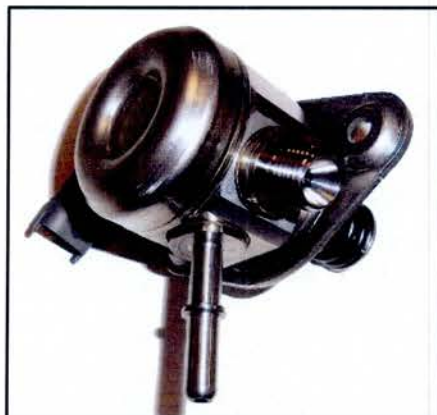
High Pressure Fuel Pump

DTC P0087 - Fuel Rail Pressure (FRP) Too Low

1. Replace the high pressure fuel pump per applicable procedure on KGIS.

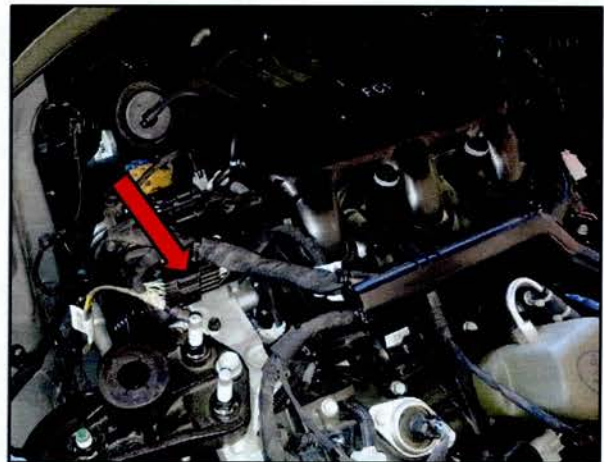
1. Check for other DTCs that would point to the low pressure fuel pump or fuel pressure sensor. Correct and repair as required.
2. Inspect the electrical connections at both the pump and the fuel pressure sensor.
 - On 3.3L GDI equipped vehicles, check connector CC22B.

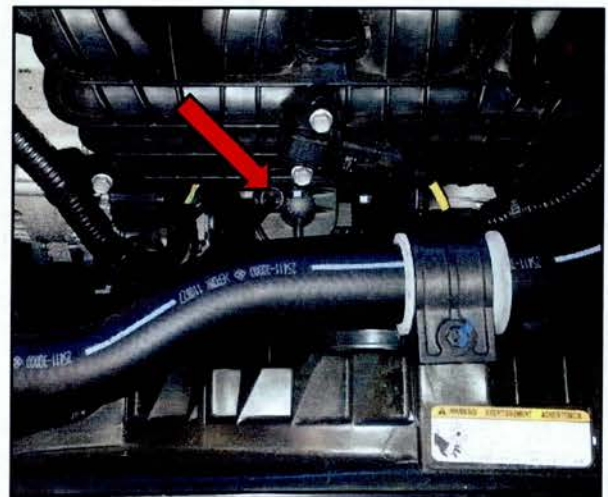
- On 2.0L and 2.4L GDI equipped vehicles, check connector CHGINJ (12-BLK).
