NEWMAR CORPORATION WARRANTY DEPARTMENT

TECHNICAL SERVICE BULLETIN																	
DATE ISSUED	MODEL YEAR(S) AFFECTED		MODEL(S) AFFECTED			TSB #											
10/11/2013	2013 & 2014		King Aire, Essex & Mountain Aire			407											
BRAND						TYPE											
All	<input type="checkbox"/>	American Star	<input type="checkbox"/>	Mountain Aire	<input checked="" type="checkbox"/>	All	<input type="checkbox"/> TT <input type="checkbox"/>										
Cypress	<input type="checkbox"/>	Dutch Star	<input type="checkbox"/>	Kountry Aire	<input type="checkbox"/>	FW	<input type="checkbox"/> CA <input type="checkbox"/>										
Northern Star	<input type="checkbox"/>	Kountry Star	<input type="checkbox"/>	Essex	<input checked="" type="checkbox"/>	DP	<input checked="" type="checkbox"/> DB <input checked="" type="checkbox"/>										
Scottsdale	<input type="checkbox"/>	King Aire	<input checked="" type="checkbox"/>	London Aire	<input type="checkbox"/>												
All Star ME	<input type="checkbox"/>	Ventana	<input type="checkbox"/>	Bay Star	<input type="checkbox"/>

G-2000/NOVA AWNING (ECO) ENGINEERING CHANGE ORDER

12 Volt Motion Sensor Upgrade Announcement

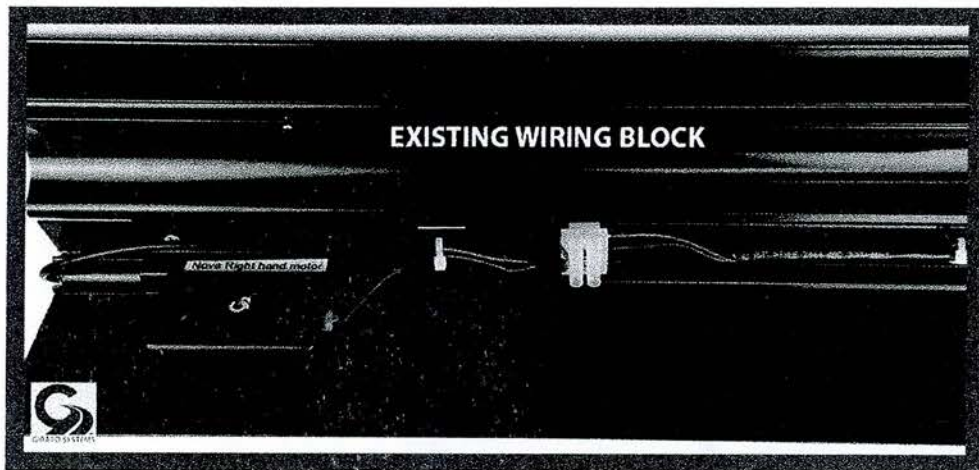
Figure 1

- A. Locate the wiring block that is supplying the motion sensor and led lighting system 12V power (if present). This should be located on the far right or far left side of the awnings' Lead Rail. (Figure 1)
- B. Make sure the 12V power has been shut off.
- C. Cut cable ties and remove wires from the existing wiring block making sure not to damage or cut any wires. Remove screws retaining the wiring block, and make sure to discard screws and old wiring block.
