SERVICE BULLETIN

APPLICABILITY: 2012 - 13MY Impreza Models with 2.0L FB Engines
2013MY XV Crosstrek

NUMBER: 02-145-13R
DATE: 09/25/13
REVISED: 10/10/13

SUBJECT: Surface Treatment Change To Oil Control
Piston Rings

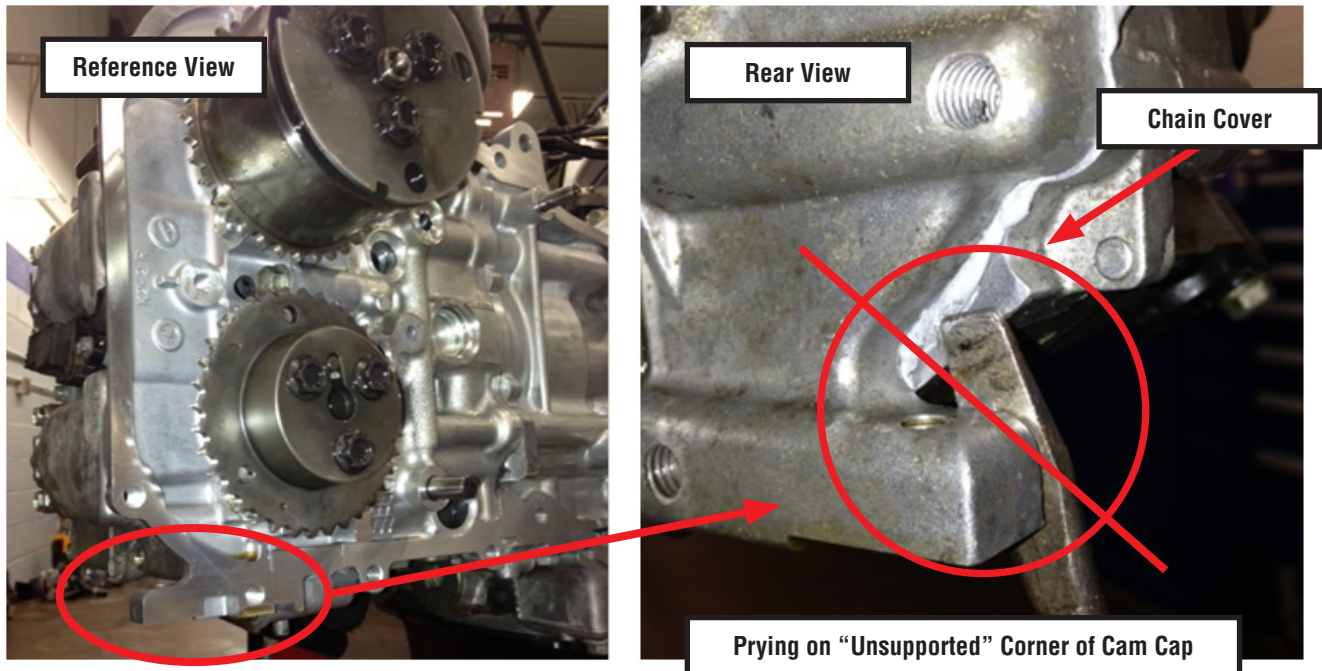
- **IMPORTANT:** After all 32 bolts securing the chain cover are removed, be **VERY** careful where you pry and what you pry on to break the silicone sealant bond. The photos below show an example of where NOT to pry. In this case, the cam cap became cracked requiring a complete cam carrier replacement. Patience is the key!
