# Technical Service Bulletin

## 97 Various electrical components inoperative

97 13 38 2016275/5 October 16, 2013. Supersedes Technical Service Bulletin Group 97 number 10-14 dated September 16, 2010 for reasons listed below.

Model(s)	Year	VIN Range	Vehicle-Specific Equipment
Q7	2007 - 2014	All	Not applicable

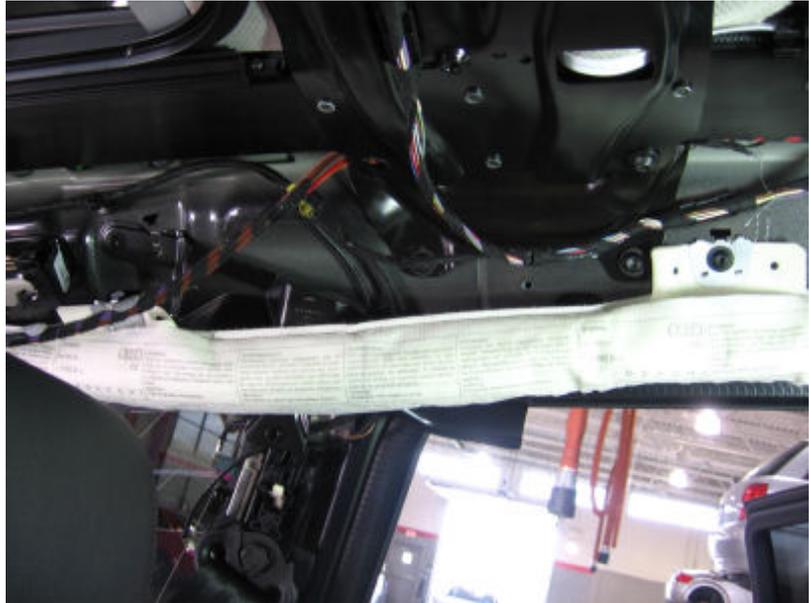
During vehicle assembly, the wire harness that is routed along the left side of the sunroof frame may be pinched at one of the sunroof frame to body assembly points (Figure 1 - Figure 4).

**Figure 1.** Sunroof frame and mounting bracket above left rear door.

Repair damaged wires using the VAS Repair Kit 1978 (Figure 5).

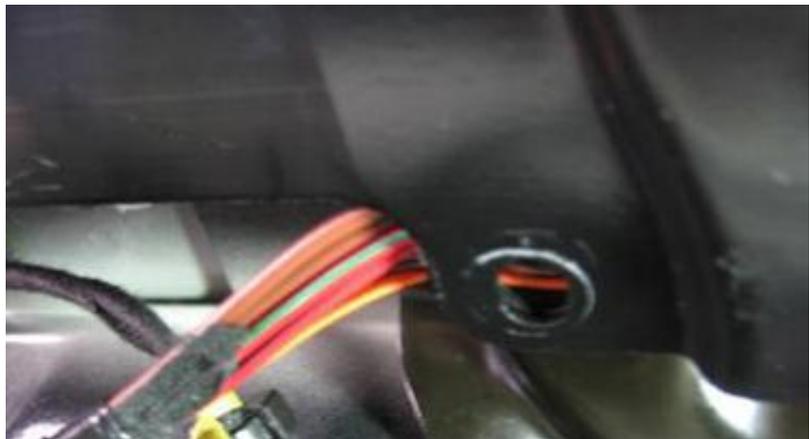
**Figure 2.** Closer view of wires that fell out of the sunroof frame groove and would become pinched between the sunroof frame and mounting bracket. Mounting bolt removed for demonstration purposes.

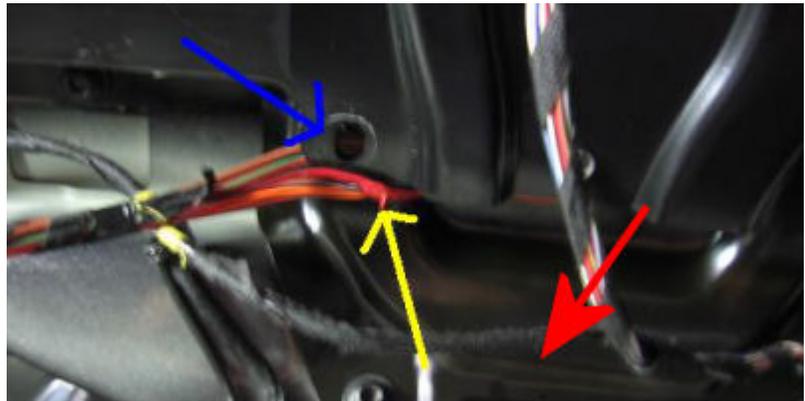
**Figure 3.** Bracket that fastens the sunroof frame to the body (red arrow), sunroof frame (blue arrow), and pinched wire (yellow arrow).

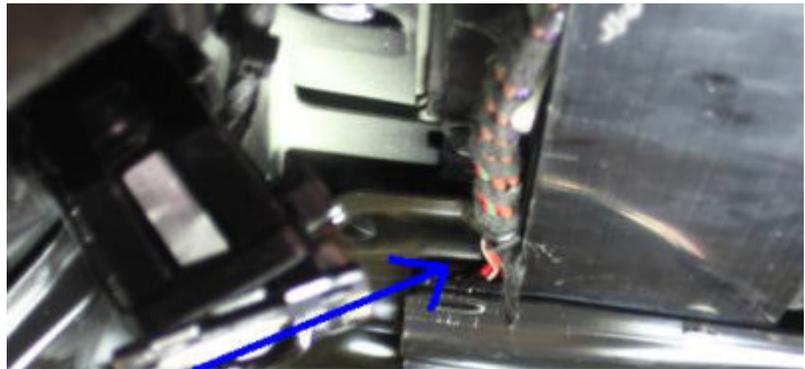
**Figure 4.** Wire, pinched between the sunroof frame and the bracket that holds the frame to the body on the left side of the vehicle above the C-pillar. Photo taken from the rear hatch opening.
