**1.6L OR 2.0L GTDI ENGINE - DRIVABILITY CONCERNS WITH DTCS
P0106, P0236 - OR ENGINE FAULT SERVICE ENGINE NOW MESSAGE
WITHOUT DTCS - BUILT ON OR BEFORE 10/24/2013****TSB 13-12-12****FORD:**

2013-2014 Escape

ISSUE

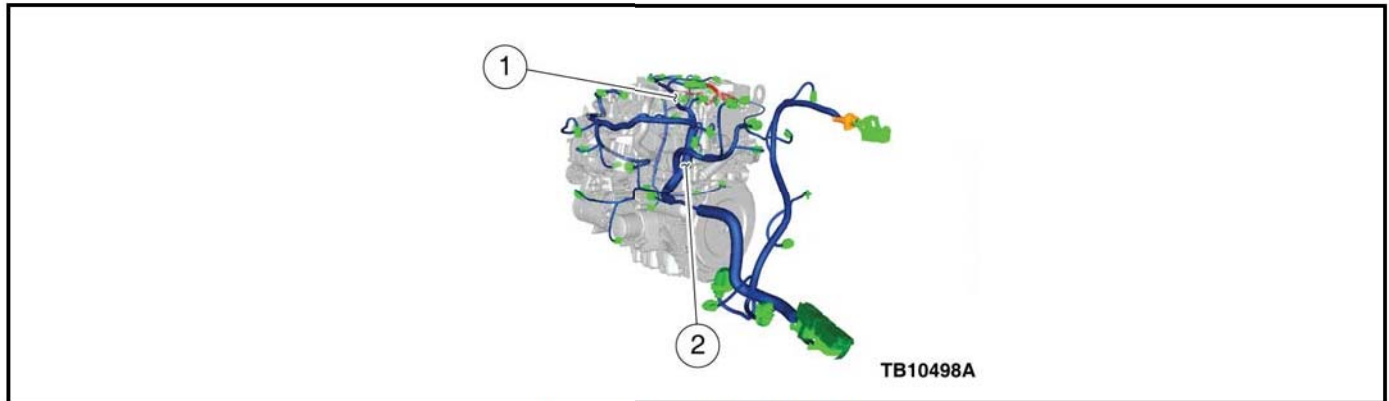
Figure 1 - Article 13-12-12

- a. 1.6L - Splice S123 can be in one of two locations depending on build date. (Figure 1 Items 1 and 2)

- (1) Remove enough harness wrap to locate and replace splice.
- (2) Backfill the crimp with solder before sealing repair with heat shrink tube.

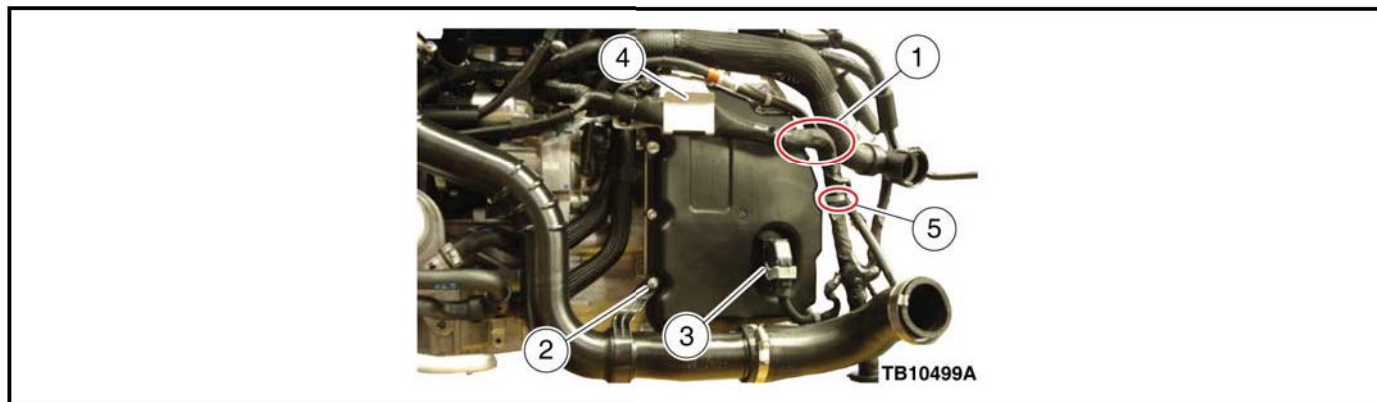
Figure 2 - Article 13-12-12

- b. 1.6L - Splice S178 is located under the air box where the 12A581 harness turns downward near the transmission cover. (Figure 2 Item 1)

- (1) Raise vehicle. Refer to Workshop Manual (WSM), Section 100-02.
 - (2) Remove lower splash shield. Refer to WSM, Section 303-01A for engine removal.

- (3) Remove nut at the transmission oil pan. (Figure 2 Item 2)
 - (4) Remove the charge air cooler tube. Refer to WSM, Section 303-12A.
 - (5) Disconnect transmission electrical connector (Figure 2, Item 3)

- (6) Disconnect the white plastic harness bracket. (Figure 2, Item 4)
 - (7) Disconnect the harness from the black harness clip. (Figure 2, Item 5)
 - (8) Pull down harness to gain access to S178.

- (9) Remove enough harness wrap to locate and replace splice.
 - (10) Backfill the crimp with solder before sealing repair with heat shrink tube.
 - (11) Reverse Steps 1 through 8 for installation.

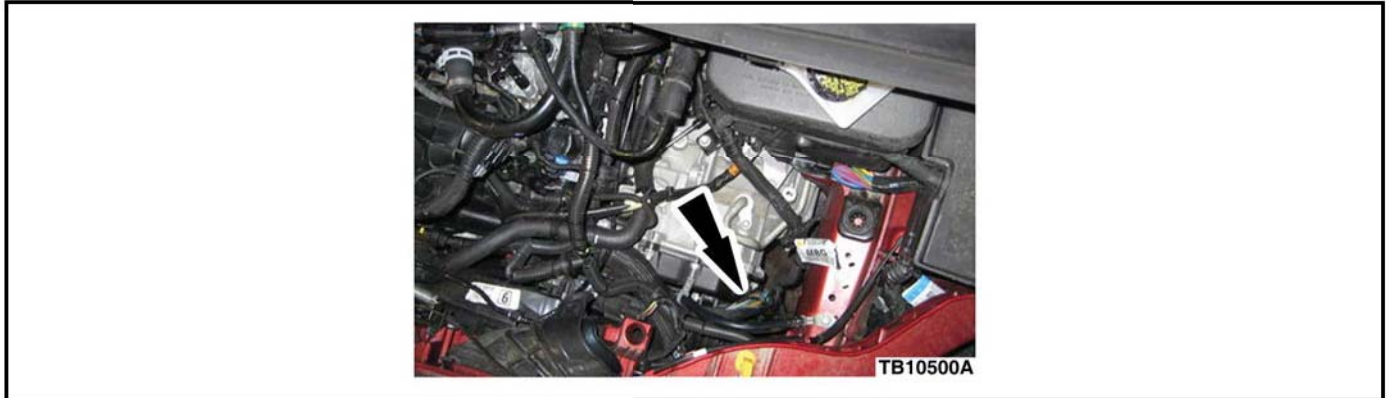
Figure 3 - Article 13-12-12

- a. 2.0L - Splice S108 is located under the air box where the harness makes a bend. (Figure 3) Splice S182 is located near the bottom of the transmission. (Figure 4)

4. Replace signal return splices with 0.75 mm (18 AWG) wire using the crimp method. Affected splice numbers are S108 and S182. Refer to Wiring Diagram, Section 5.1.

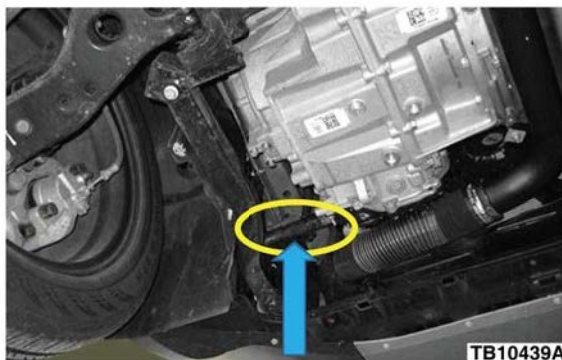
Figure 6 - Article 13-12-12

5. If the vehicle exhibits a driveability concern along with an engine fault Service Engine Now message in the Instrument Panel Cluster (IPC) message center without any DTCs stored in PCM memory, perform wiggle test on Powertrain Control Module engine harness (12A581) while monitoring MAP, TCBP and BARO Sensors PSI with IDS. Refer to Figures 1-4 and 6-7 for wiggle test locations. If signal noise or VREF pull down is confirmed during harness wiggle test, replace signal return splices with 0.75 mm (18 AWG) wire using the crimp method per Step 3 for 1.6L or Step 4 for 2.0L.
 - a. a. 1.6L or 2.0L GTDI engine wiggle test here by pushing and pulling on the harness lightly while monitoring MAP, TCBP, BARO at key on engine off (KOEO). (Figure 6)

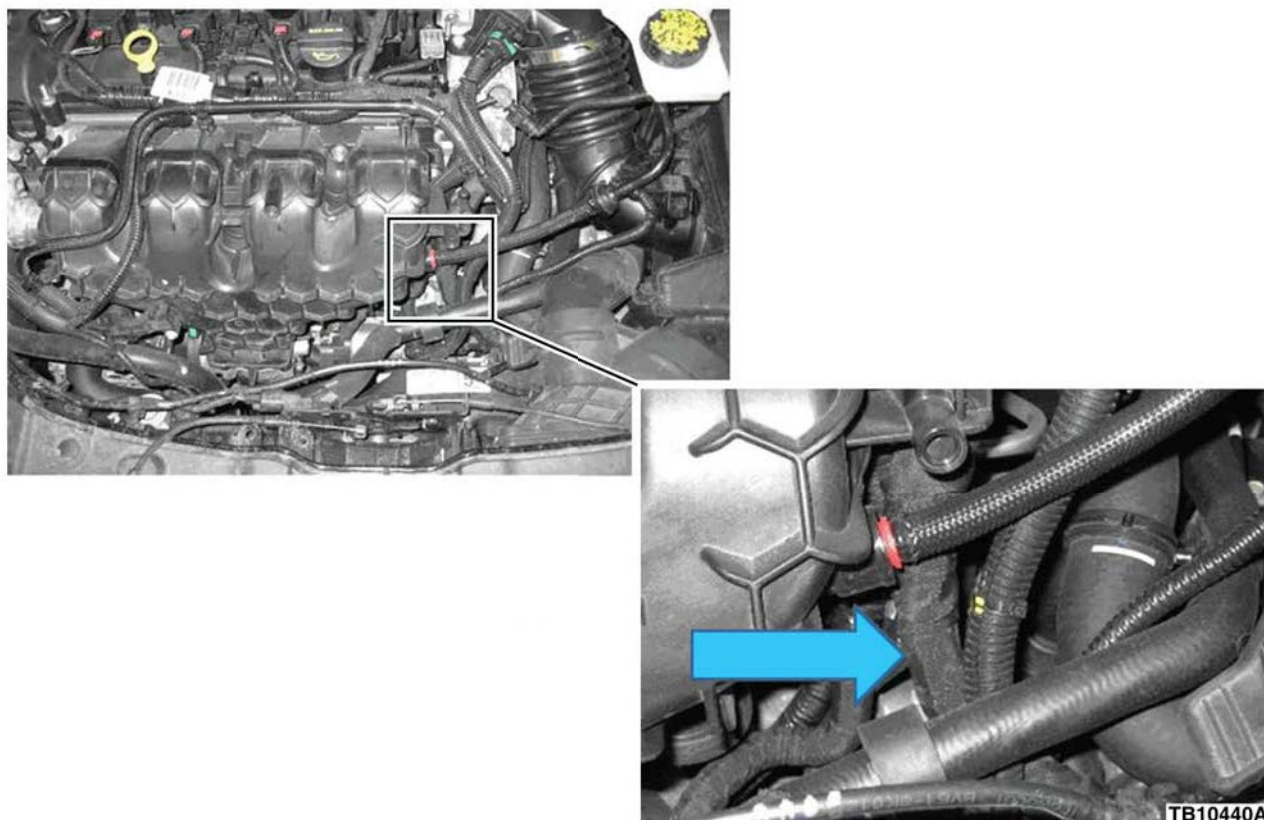
Figure 7 - Article 13-12-12

- b. 2.0L GTDI engine wiggle test here by pushing and pulling on the harness lightly while monitoring MAP, TCBP, BARO pressure in PSI units at KOEO. (Figure 7)
