## **Vehicle Owner Notification**

**Subject:** VON # 84 SAF-T-Liner HDX Turbo Coolant Line Replacement.

**Date:** 09/20/2013

## Subject: Saf-T-Liner HDX 90 degree elbow and fitting replacement

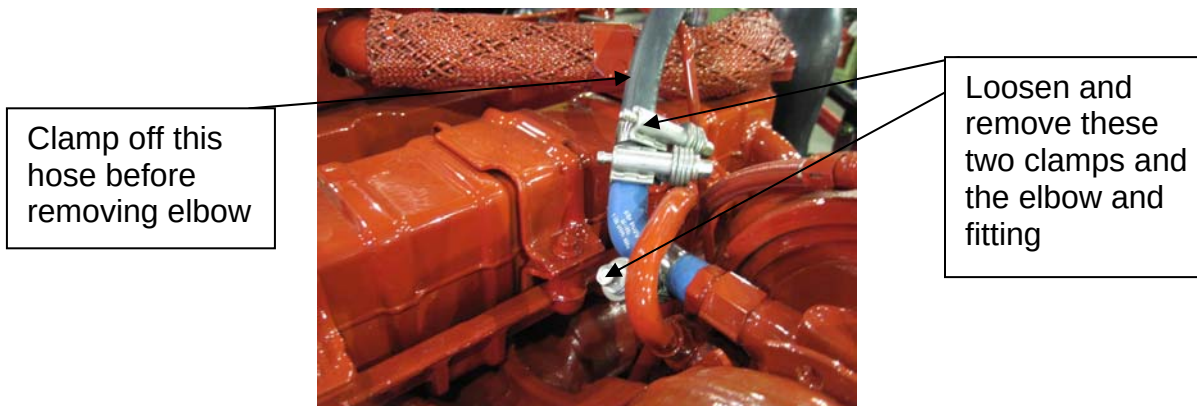
Enclosed are copies of the customer notification letter and the repair procedure for customers who have purchased certain Thomas Built Bus Type D HDX units with CNG engines. Thomas has determined that the fitting and/or hose located on the top of the engine could crack.

2) Locate hose above the top Constant torque clamp. Clamp off this hose before removing elbow. (Figure 1)

3) Locate the elbow that is located near the turbo on the Cummins CNG engine. It will have a Constant torque clamp on each end and then there will be one on other side of fitting. Loosen the one at the entrance to engine and the one that is on other side of fitting using a 5/16 socket. Remove and discard fitting, (Elbow hose if installing new one) and all three constant torque clamps. (See Figure 1 for location of clamps and which ones to loosen and discard)
