Clutch-Related No-Start Diagnostics

Freightliner
Service Bulletin

Description of Revisions: *This bulletin replaces the version dated December 2012. The list of symptoms and troubleshooting diagnostics have been revised.*

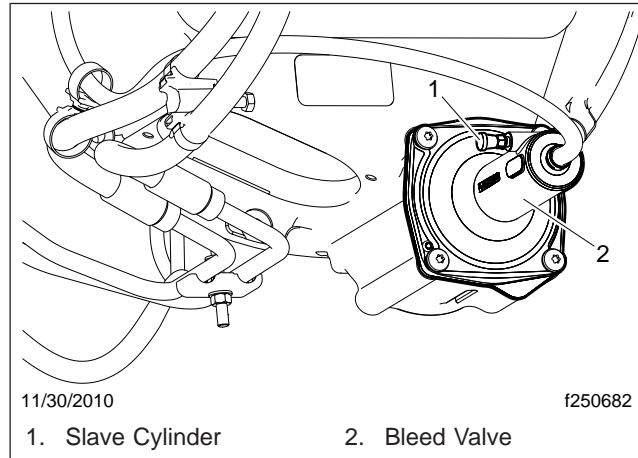
Fig. 4, Slave Cylinder Bleed Valve

- Continue to monitor the SAM Cab ECU while having an assistant open the bleed valve on the slave cylinder (see Fig. 4), allowing the pedal to travel all the way to the floor. Have the assistant close the valve. Does the actuation of the pedal switch register on the "Bottom of Clutch Circuit" indicator? If necessary, top off fluid with DOT 4 brake fluid.

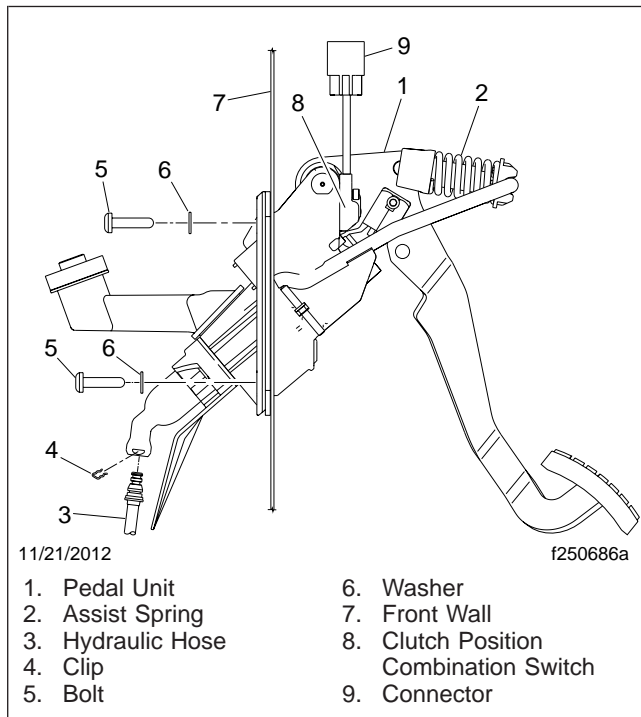
Fig. 5, Clutch Pedal Assembly

- Disconnect the chassis harness from the clutch position combination switch. See Fig. 5.
- Use a jumper wire to close the clutch low position control circuit on the chassis side (between pins A and C in Table 1), and look for a response on the SAM Cab ECU template. Does the response register on the template?

If YES, replace the switch with the newer version that is marked with a yellow dot, indicating the seal has been removed. See Cascadia Workshop Manual, Section 25.01, Subject 150.

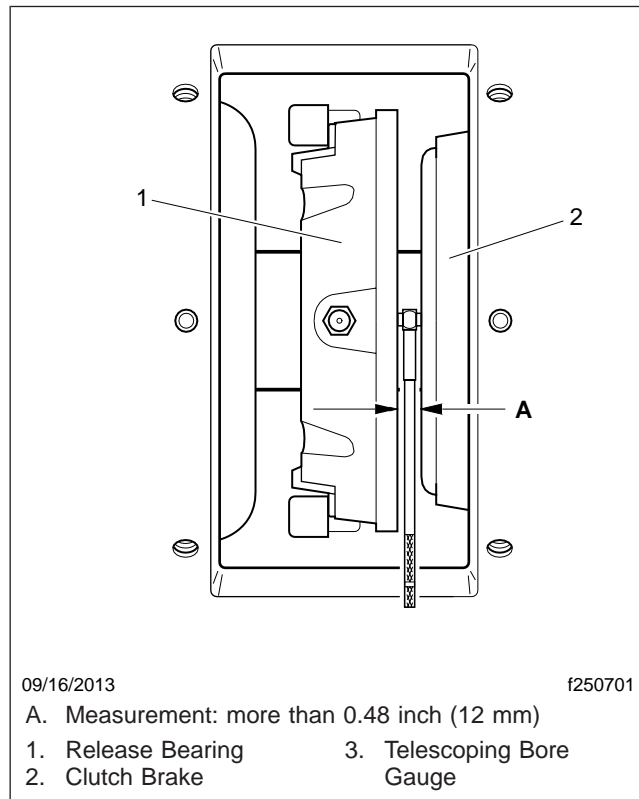
Fig. 6, Clutch Gap

- Remove the clutch inspection cover.
- Using a telescoping bore gauge, measure the gap between the clutch brake and the release bearing, then measure the gauge with a digital caliper. The distance should be more than 0.48 inch (12 mm). See [Fig. 6](#).

If the distance is correct, install the inspection cover. Tighten the screws 14 to 18 lbf-ft (19 to 24 N·m). Replace the hydraulic pedal assembly. See *Cascadia Workshop Manual*, **Section 25.01**.

If the distance is less than 0.48 inch (12 mm), reset the clutch (see “Resetting the Clutch”).

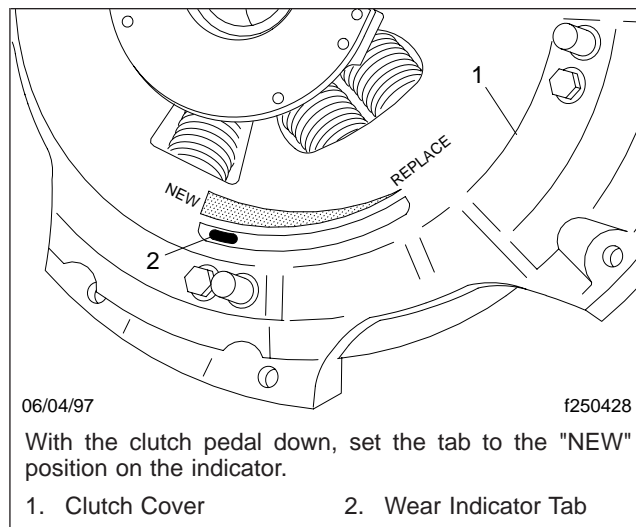
Fig. 7, Resetting the Wear Indicator Tab

- With the parking brake applied and the tires chocked, have an assistant hold the clutch pedal down.
- With the pedal held down, move the wear indicator tab to the left (NEW) position. See [Fig. 7](#).

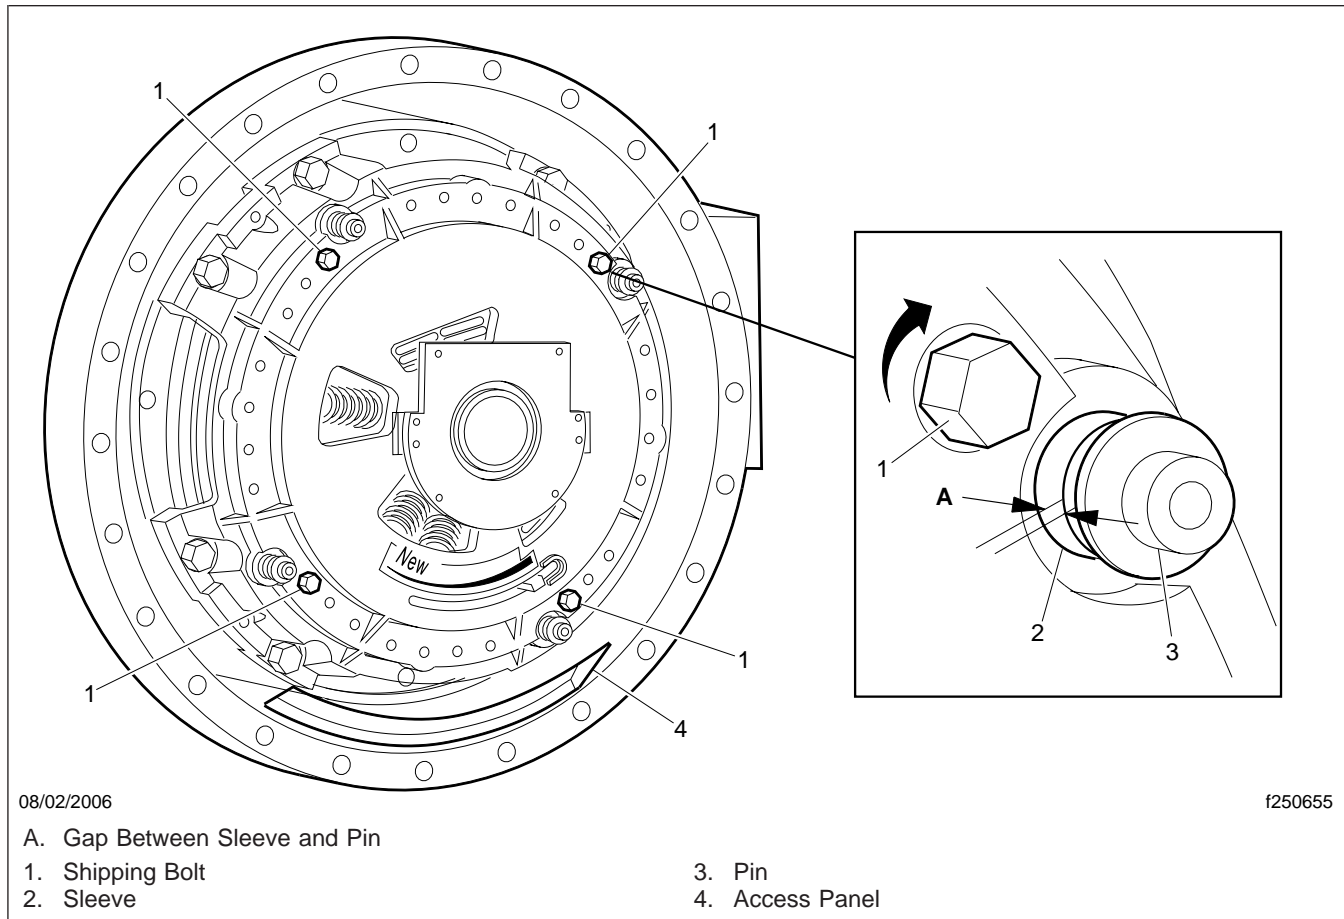
Fig. 8, Removing the Gap Between Sleeve and Pin

IMPORTANT: To prevent the clutch from returning to an over-adjusted position, the gaps between the sleeves and pins have to be eliminated, as detailed below.

5. Install four shipping bolts (7/16-14 x 1-3/4 UNC) next to the sleeves and pins, as shown in **Fig. 8**. Tighten the bolts so that the gaps between the sleeves and pins are eliminated.
