SB-10054444-8096

Technical Service Bulletin

SUBJECT:		No:	TSB-13-13-008
MIL ILLUMINATION WITH DTCS P061A/P1235 OR P0068/P1241-REVISED		DATE:	November, 2013
		MODEL:	See below
CIRCULATE TO:	<input type="checkbox"/> GENERAL MANAGER	<input checked="" type="checkbox"/> PARTS MANAGER	<input checked="" type="checkbox"/> TECHNICIAN
<input checked="" type="checkbox"/> SERVICE ADVISOR	<input checked="" type="checkbox"/> SERVICE MANAGER	<input checked="" type="checkbox"/> WARRANTY PROCESSOR	<input type="checkbox"/> SALES MANAGER

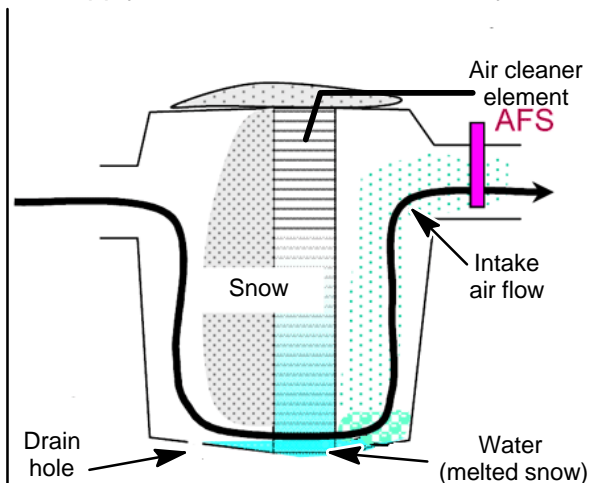
Customers of some affected vehicles may report an illuminated MIL ("Service Engine Soon" light) with the subject DTCs stored in ECM memory and/or reduced engine performance. When driving in a heavy snowstorm, snow may be drawn into the air intake and accumulate on the air filter element. After the engine is stopped, higher underhood temperatures can cause snow on the lower part of the element to melt. The water accumulates at the bottom of the air cleaner body on both sides of the filter element. When the engine is restarted, if the upper part of the element is still clogged with snow, intake air passes through the lower section of the air cleaner element and water is drawn through the air flow sensor and affects sensor readings. This causes the system to go into failsafe mode resulting in reduced engine performance. This condition is not a malfunction but a temporary result of transient "noise" from the air flow sensor. The system resumes normal operation once the air cleaner element dries.

This Technical Service Bulletin provides instructions to modify the air cleaner body seal to allow residual water to completely drain from the air cleaner body.
