SB-10054473-3570

Service Regeneration Failure
MP7 EPA2010
CXU, GU

FSB 284-044, Service Regeneration Failure

(September 2013)

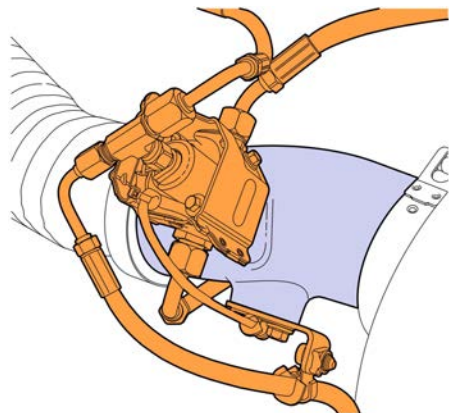
W2078571

Non-Integrated Aftertreatment Doser System

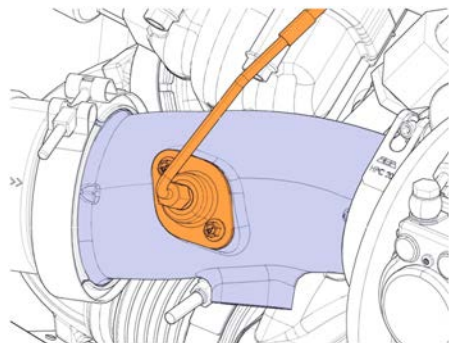
W2078693

Integrated Aftertreatment Doser System

If a service regeneration fails with intake pressures higher than 83 kPa (12 psi), check the software level in the engine control module (ECM).

Integrated Aftertreatment Doser Dataset 2	CXU, GU	22089407 or less	Proceed with software update
		22257273 or higher	Open an eService Case to Tech Support and report the issue
	Mack Twin Steer	22089408 or less	Proceed with software update
		22257274 or higher	Open an eService Case to Tech Support and report the issue

Note: A DPF Service Regeneration is required when programming is complete.
