PREVOST

WARRANTY BULLETIN

WB13-56

DATE :	SEPTEMBER 2013	SECTION :	12 - Brakes
EXPIRATION:	SEPTEMBER 2015		
SUBJECT :	AIR LEAK ON AIR DRYER PROBE

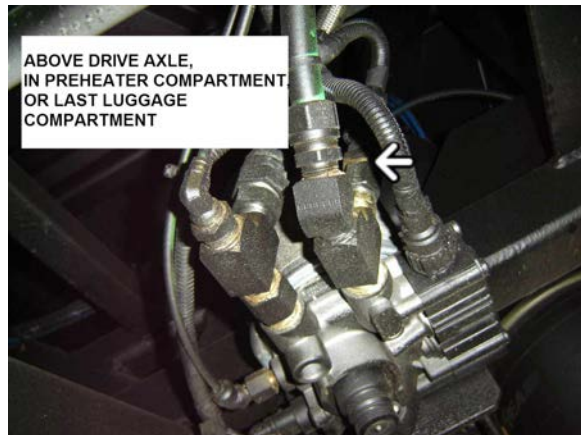
1. Lift vehicle
2. Release air pressure by front service compartment drain valve.
3. Air dryer may be located in one of these three locations :
 - A. Above drive axle, left side
 - B. In Spheros preheater compartment.
 - C. In last luggage compartment on the aft wall.

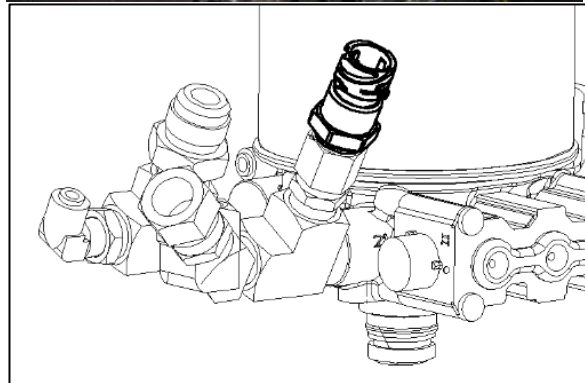
4. Disconnect and unscrew the probe, leaving the fitting on the air dryer (unscrew only the probe).

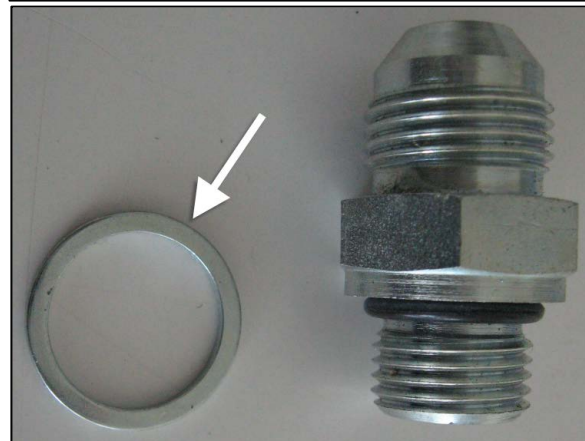
5. If you have fitting 641294, take this ring to install on the probe.

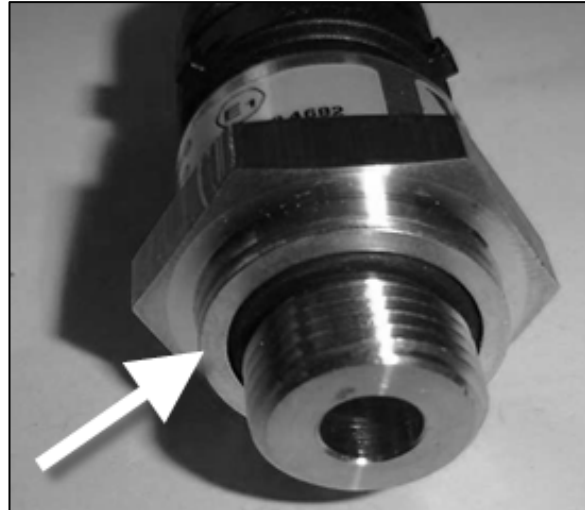
On the vehicles affected by this bulletin, the air dryer assembly may present a leak at the pressure probe connection. The O-ring in this location may be deformed due to the fitting arrangement. Adding a metal ring will prevent this issue.

6. Add ring 504789 at arrow location and re-install probe on air dryer assembly.

7. Reconnect probe and verify for air leaks.
Ensure system operates correctly.

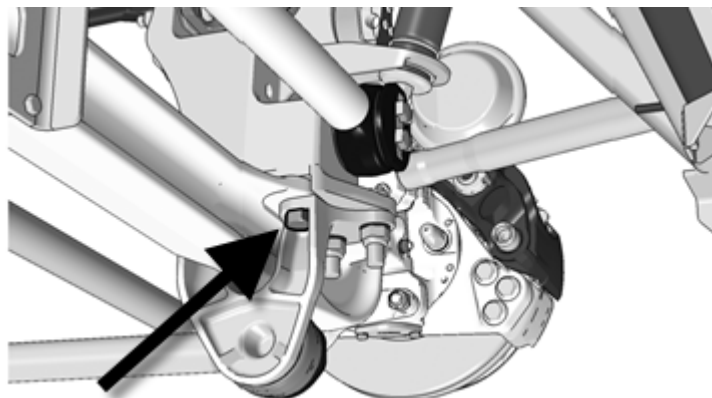
On the vehicles affected by this bulletin, torque must be verified on one of the axle support mounting bolts.

1. On the front axle, left side (driver's side). Locate this bolt (arrow).

2. Verify the torque on this bolt.

Value should be

255 +/- 25 lbf-ft. (**230 - 280** lbf-ft).
