**SB-10054507-4133**

Service Regeneration Failure  
MP7 EPA2010  
CXU, GU

## FSB 284-044, Service Regeneration Failure

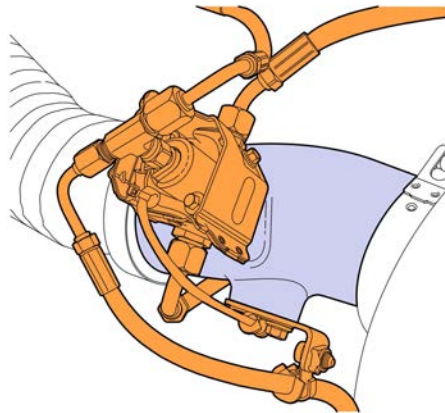
W2078571

Non-Integrated Aftertreatment Doser System

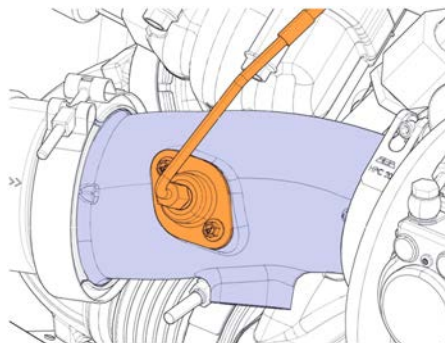
W2078693

Integrated Aftertreatment Doser System

If a service regeneration fails with intake pressures higher than 83 kPa (12 psi), check the software level in the engine control module (ECM).

Integrated Aftertreatment Doser Dataset 2	CXU, GU	22089407 or less	Proceed with software update
		22257273 or higher	Open an eService Case to Tech Support and report the issue
	Mack Twin Steer	22089408 or less	Proceed with software update
		22257274 or higher	Open an eService Case to Tech Support and report the issue
