**SB-10054591-4655**

SI B51 17 13  
Body Equipment

**Bolt for Tailgate Strut Holder Corroded**

F25

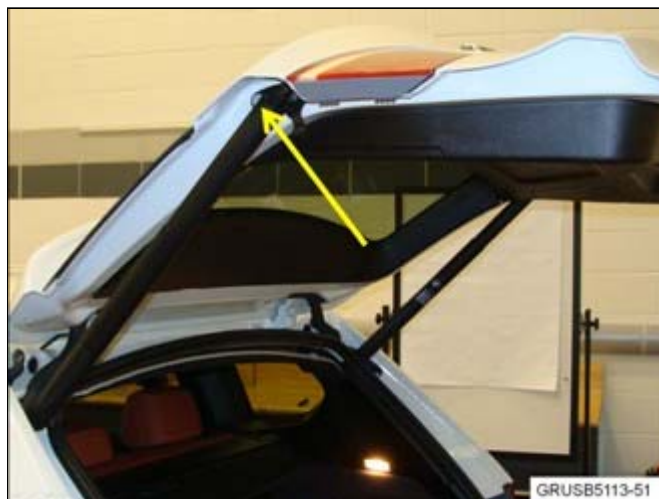
1. Locate the hex bolt securing the tailgate strut holder. Shown is the driver's side tailgate strut. Support the tailgate with a suitable device. Using Repair Instruction 51 24 350, remove the tailgate strut/spindle drive.

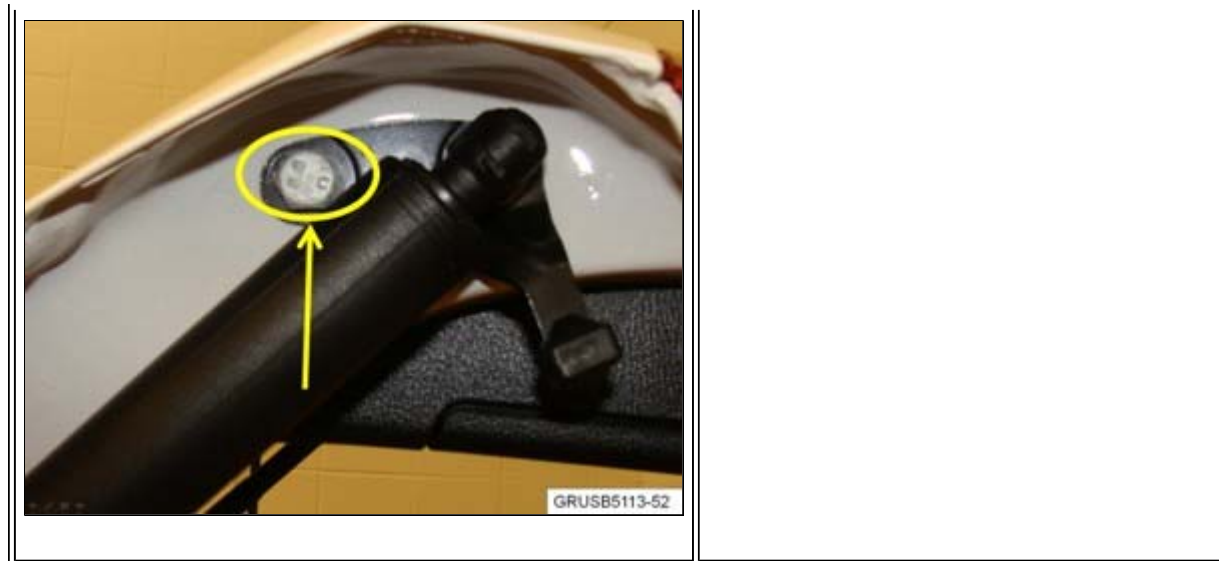
The customer may notice traces of corrosion on the bolt securing the tailgate strut.

Corrosion protection coating of the bolt was below BMW specifications.

2. This is a close-up picture of the hex bolt securing the tailgate strut holder. If corrosion is seen on either the driver's or passenger's side, replace the bolt with the part number listed below and torque to 38 Nm. The new bolt has an improved corrosion protection.

Replace the corroded hexagon bolt.
