SB-10054641-5354

SI B12 19 13
Engine Electrical Systems

Service Action: Program Control Units (Oil Level Sensor)

All with the N63T engine

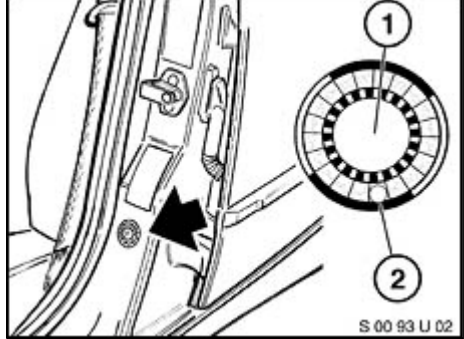
<p>This Service Action has been assigned code number 656. After the vehicle has been checked and/or corrected, obtain a label (SD 92-420) and:</p> <ul style="list-style-type: none"> A. Emboss your BMW center warranty number in the middle of the label (1); B. Punch out code number 656 (2), printed on the label; and C. Affix the label to the B-pillar as shown.
---	---

If the vehicle already has a label from a previous Campaign, affix the new label next to the old one. Do not affix one label on top of another one because a number from an underlying label could appear in the punched-out hole of the new label.
