SB-10054642-9560

SI B61 18 13
General Electrical Systems

Service Action: Program Control Units (CAS)

F12

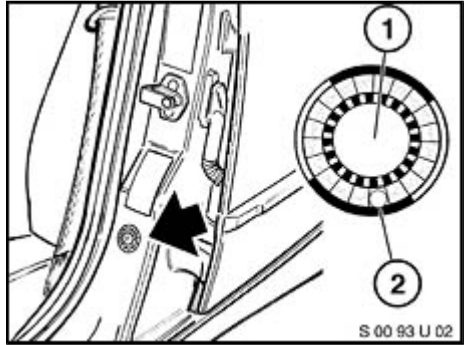
<p>This Service Action has been assigned code number 655. After the vehicle has been checked and/or corrected, obtain a label (SD 92-420) and:</p> <ul style="list-style-type: none"> A. Emboss your BMW center warranty number in the middle of the label (1); B. Punch out code number 655 (2), printed on the label; and C. Affix the label to the B-pillar as shown.
---	---

If the vehicle already has a label from a previous Campaign, affix the new label next to the old one. Do not affix one label on top of another one because a number from an underlying label could appear in the punched-out hole of the new label.
