Technical Bulletin

Section Title: Engine
 TSB No. TS 35 12103

SUBJECT: SPECIAL COVERAGE EXTENSION FOR SPECIFIC CRACK(S) IN THE CYLINDER HEAD.

MODEL(S): GRAND VITARA (JB) WITH 2.4L ENGINE

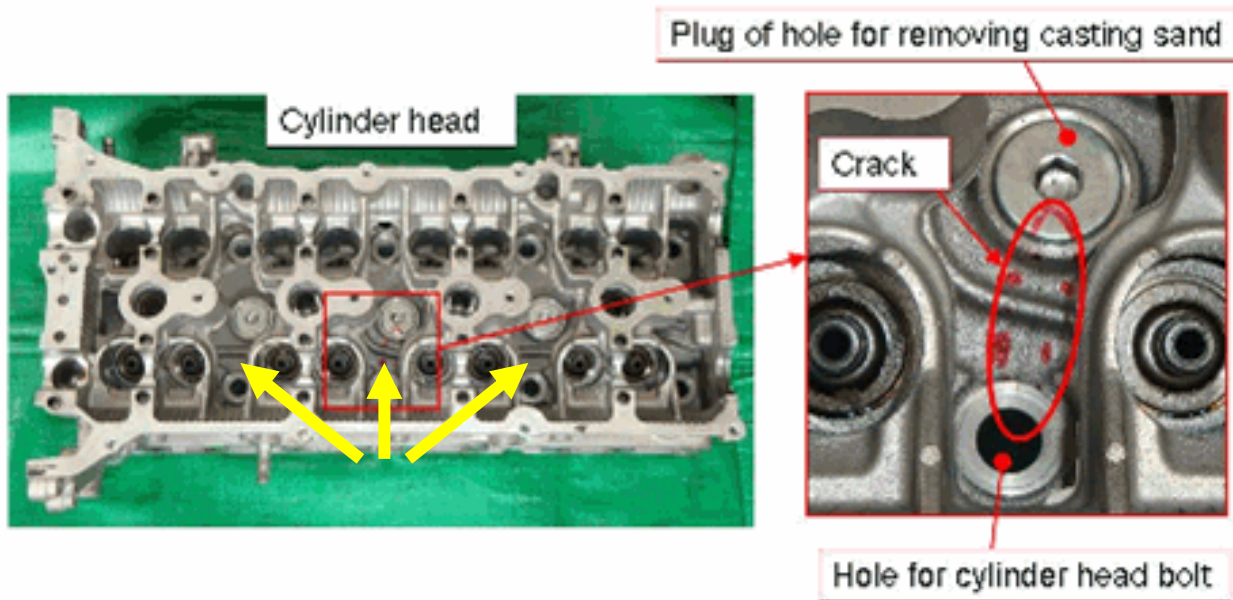
FAILURE AREA

CAUSE: Suzuki has determined that certain 2009 Grand Vitara vehicles may develop a crack(s) between cylinder head bolt(s) and casting plug(s).

Cracks located in the 3 areas indicated by arrows may be eligible for coverage.

CORRECTION: A special coverage extension will apply for vehicles beyond the basic warranty limits. The coverage allows repairs to be made for customers at no charge for parts and labor up to 7 years or 102,000 miles, whichever comes first, from the date of first use, at authorized Suzuki service points. Cracks in locations other than the specified areas of the cylinder head do not qualify for the coverage extension.
