**LACK OF AIR CONDITIONING AND/OR ENGINE OVERHEAT CONDITION
- BUILT ON OR AFTER 9/1/2010**

TSB 13-12-21

2011-2012 Taurus

This article supersedes TSB **12-10-3** to update the Service Procedure and Part List.

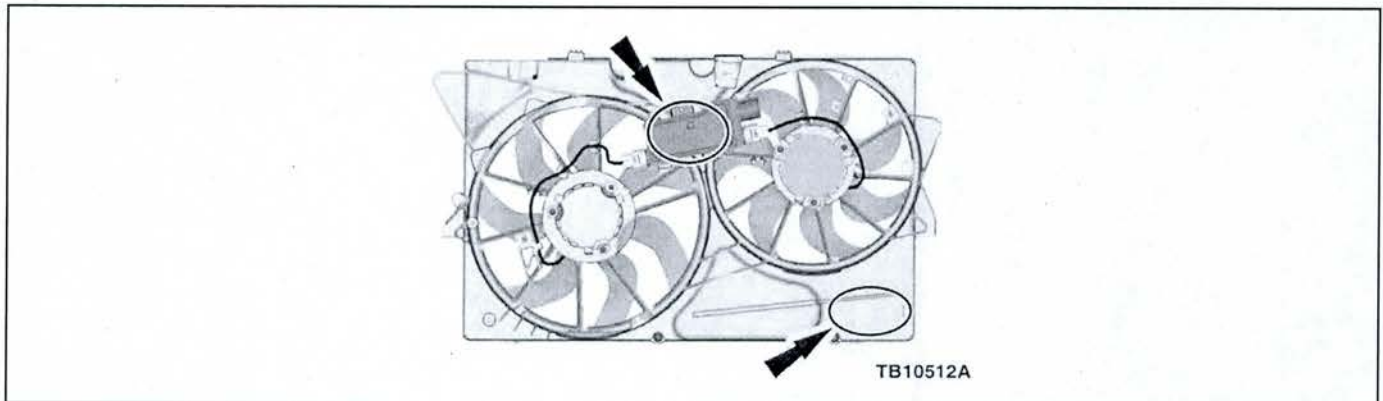
Figure 1 - Article 13-12-21

- a. No - please be sure to check the fan assembly for being original equipment manufacturer (OEM). (Figure 1)

- (1) For Taurus and MKS vehicles, replace the cooling fan motor and control module assembly. Refer to Workshop Manual (WSM), Section 303-03 and then proceed to Step 5.
- (2) For Explorer, Flex and MKT vehicles, proceed to Step 3.

3. Remove the cooling fan motor and control module assembly. Refer to WSM, Section 303-03.
4. Remove the cooling fan control module from the original cooling fan motor assembly and transfer onto the new cooling fan motor assembly. Tighten screw to 7 Nm (60 lb-in).
5. Install the new cooling fan motor assembly. Refer to WSM, Section 303-03.
6. Check coolant level and top off as necessary using the correct coolant type. Refer to WSM, Section 303-03
