SI B61 16 13  
General Electrical Systems

**Service Action: Check and, If Necessary, Replace Battery**

E93

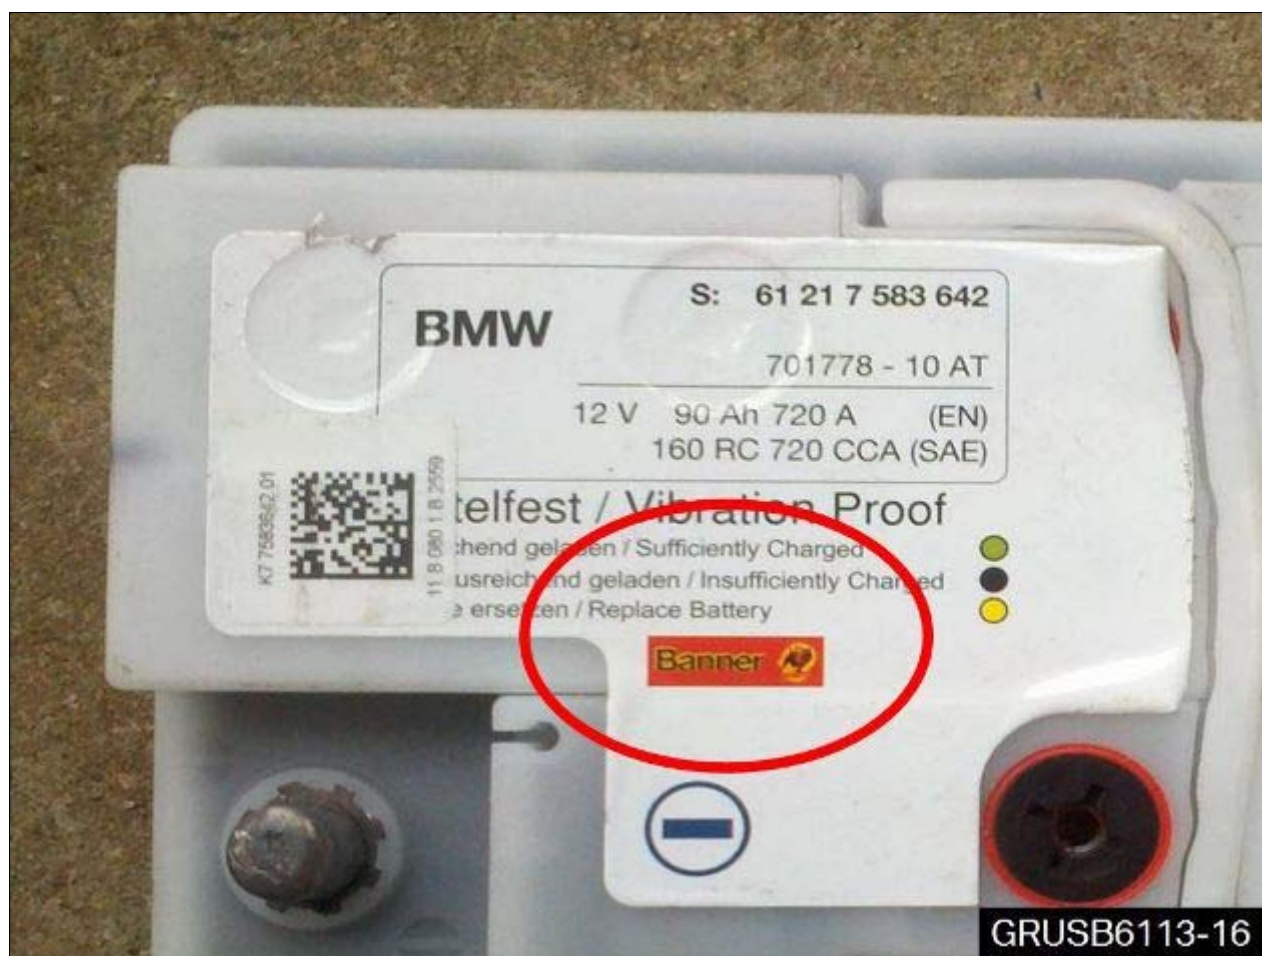
The battery installed in an E93 has an increased failure rate, which in extreme cases can cause a breakdown.

Defective batteries produced by “Banner” have exhibited a shortened lifespan.

Check the installed battery and determine if the battery housing is white and produced by “Banner,” as indicated by the identification below.

**NEW** If the battery housing is white and has the “Banner” identification, replace and register the battery (select “1 Enter battery replacement: Same capacity” during battery registration) as per ISTA Repair Instruction 61 21 010, “Remove and Replace the Battery.”

**NEW** If the battery’s housing is black and does or does not have the “Banner” identification, no further repair is needed. Install the label code and refer to the applicable warranty information section.
