Technical Service Bulletin

Topic	Air Bag Warning - Resistance Related Fault Codes
Market area	United States E05 Bentley USA and rest America (6E05)
Brand	Bentley
Transaction No.	2033170/2
Level	EH
Status	Released for publishing
Release date	Dec 20, 2013

Air bag warning displayed

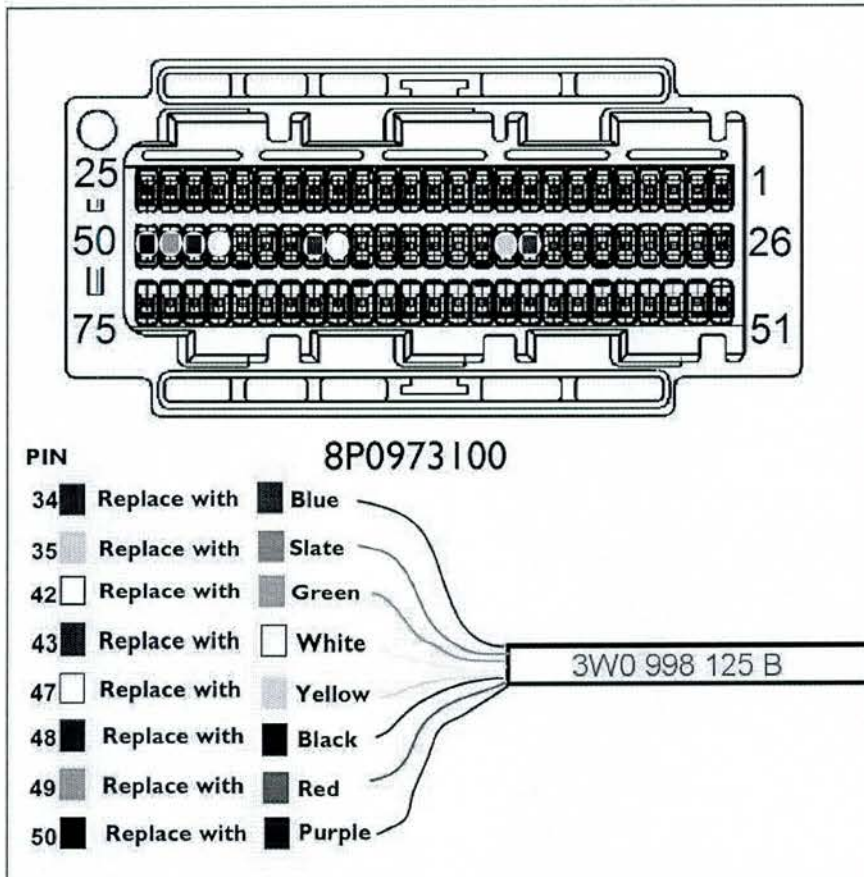
Figure 13

Note: A sample of vehicles may have the white and brown cables in cavity 47 and 48 transposed this is expected and despite this the new harness cables should be inserted into the cavities as shown in figure 13. This is the yellow in cavity 47 and the black in cavity 48

22. Identify the eight wires that have to be removed from the housing (see Figure 13). Note: figure 13 shows the connector face (not cable entry). The left hand list and the plug detail depicts the cable colours originally in the harness. The new cable colours are shown associated with the new harness (part number 3W0 998 125B)

24. With the new harness in position fit each of the eight new wires in turn into the correct cavities as detailed in figure 13. Note: the correct orientation of the locking lance when fitting the new terminals into the centre row of cavities in the housing (see Figure 14)
