T-SB-0172-13

November 22, 2013

# ABS Brake Noise with DTC C1431

YEAR(S)	MODEL(S)	ADDITIONAL INFORMATION
2012 – 2013	Camry

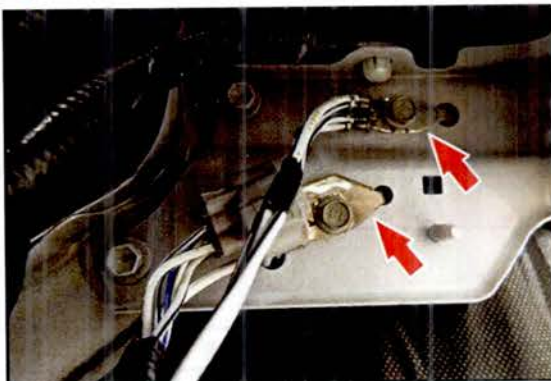
Figure 1.

- 2012 / 2013 Camry:  
*Brake – Brake Control/ Dynamic Control Systems – “Vehicle Stability Control System: C1430, C1431; Brake Pedal Load Sensing Switch OFF Stuck Malfunction”*
2. If the brake pedal load sensing switch is judged OK, check the resistance at connector A40 Pin 1 to body ground. Is the resistance always below 1 ohm?
    - **YES** – Continue diagnosis using the Repair Manual.
    - **NO** – Proceed to step 3.
  3. With the battery connected, perform voltage drop test from the two left fender bracket ground wire eyelet tabs to body ground (see Figure 1).

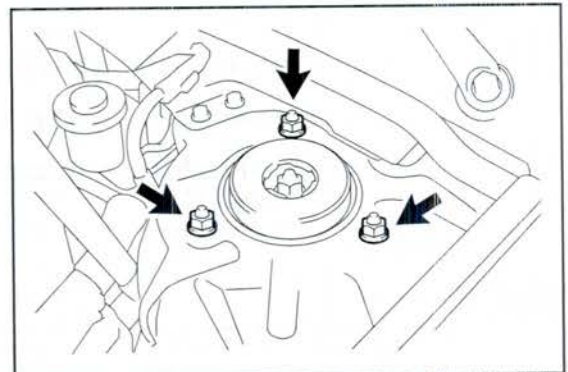
Figure 2.

- A. Use a left front strut tower mounting bolt as a good body ground (see Figure 2).

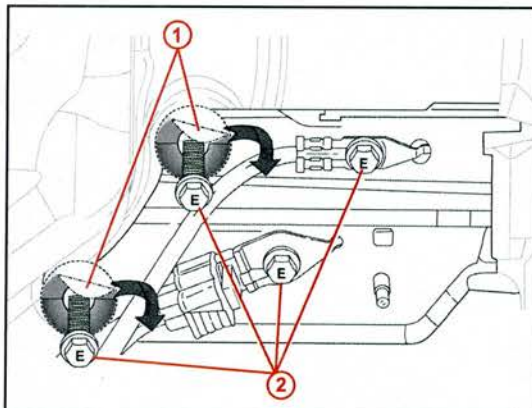
Figure 3.

4. Is voltage drop from each ground location less than 0.2 volts?
  - **YES** – Continue diagnosis using the applicable Repair Manual.
  - **NO** – A voltage drop of 0.2 volts or more from either of the ground locations may indicate poor continuity in the ground circuit. Proceed to step 5.
5. With the battery disconnected, remove the left hand fender bracket from the apron for inspection.
6. Inspect the grounds on the left hand fender bracket. Confirm the following:
  - Ground bolts are “E” bolts (see Figures 3 and 5).
  - Apron bolts should be “E” bolts if left hand fender bracket has been replaced (see Figures 3 and 5).
  - The area around the bracket to apron mounting bolt holes (see Figure 4) is free of paint.
  - The area around the apron mounting bolt holes do not show masking tape or painted masking tape (see Figures 3 and 4).

<b>1</b>	Confirm Green Masking Tape Is Removed
<b>2</b>	Confirm “E” Bolts Are Installed

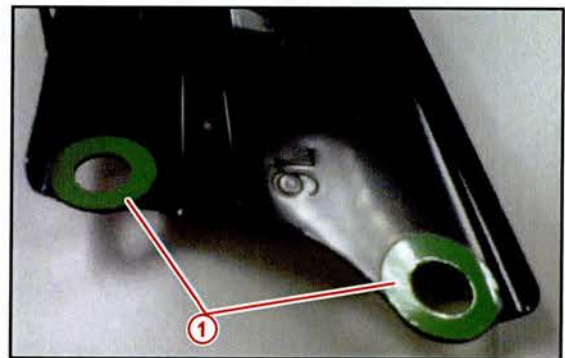
Figure 4.

<b>1</b>	Masking Tape — REMOVE After Painting, NO Paint in This Area
----------	---

7. Is there masking tape or painted masking tape or paint around the apron bolt holes?
- **NO** — Replace the left hand fender bracket.
  - **YES** — Remove the tape or paint and continue to step 8.

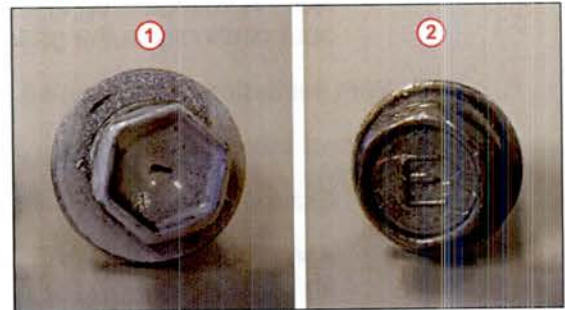
Figure 5.

- It is important that the bracket to apron mounting bolts/washers are free of paint on the front portion of the bracket.
- The new part number bracket comes with instructions that should be followed carefully when replacing.
- The new bracket also comes with green tape around the apron mounting bolts to protect it during the painting phase (see Figures 3 and 4). *This green masking tape MUST be removed in order for the bracket to be properly installed on the vehicle.*
- The new bracket includes new apron "E" mounting bolts. It is important that the new "E" bolts are used and are torqued properly. See Figure 5 on how to identify new bolts.

1	Old Bolt: DO NOT USE or Reuse These Bolts
2	NEW "E" Bolt

Torque: Ground Bolts:  
6.9 – 9.8 N\*m (70 – 100 kgf\*cm,  
5.1 – 7.2 ft\*lbf)

Torque: Bracket to Apron Bolts:  
3.9 – 8.8 N\*m (40 – 90 kgf\*cm,  
2.8 – 6.5 ft\*lbf)
