Service Bulletin

Subject: VARIOUS ELECTRICAL SYSTEM MALFUNCTION(S) RELATED TO C-15 CONNECTOR CORROSION	Bulletin No: 09-031/13
	Last Issued: 11/11/2013

2013-2014 CX-5 vehicles with VINs lower than JM3KE****365953 (produced before June 25, 2013)

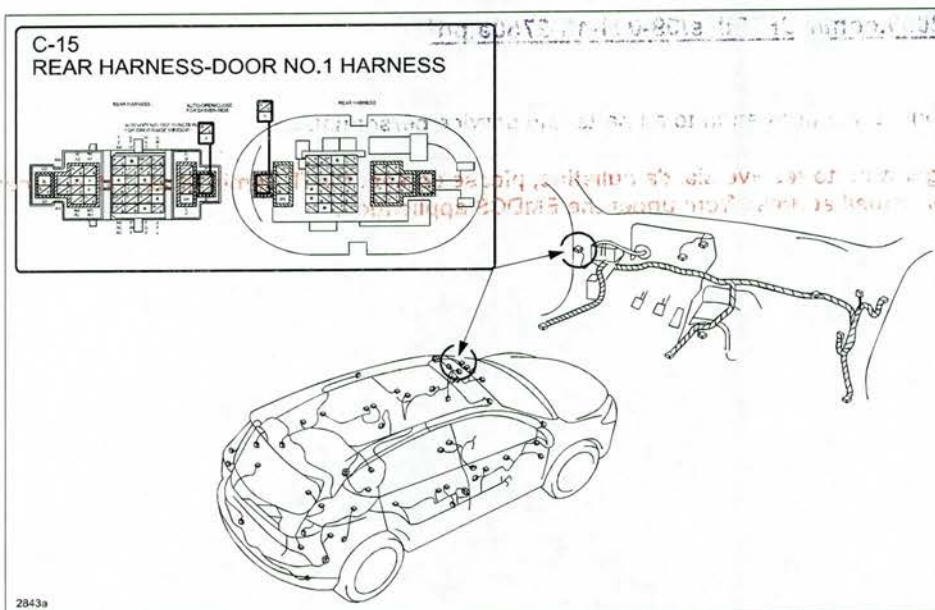
Some vehicles may experience one or more of the following symptoms in connection with a malfunction related to the C-15 connector.

- The driver side power window does not operate.
- The door does not open when using the advanced keyless system.
- The warning lamp stays ON even after the ignition switch is turned OFF.

The symptoms listed above may be caused by corrosion of the C-15 connector terminals due to water intrusion through the front door. In low ambient temperatures, the door harness hardens. If the door is fully opened, it may create a gap between the door and the door harness grommet, which may allow water to enter through the gap.

- The front door harness grommet has been changed to improve sealing performance.
- Holes inside the front pillar (which are made for weight reduction), have been covered to prevent water intrusion.

Customers with this concern should have their vehicle repaired according to the following repair information.

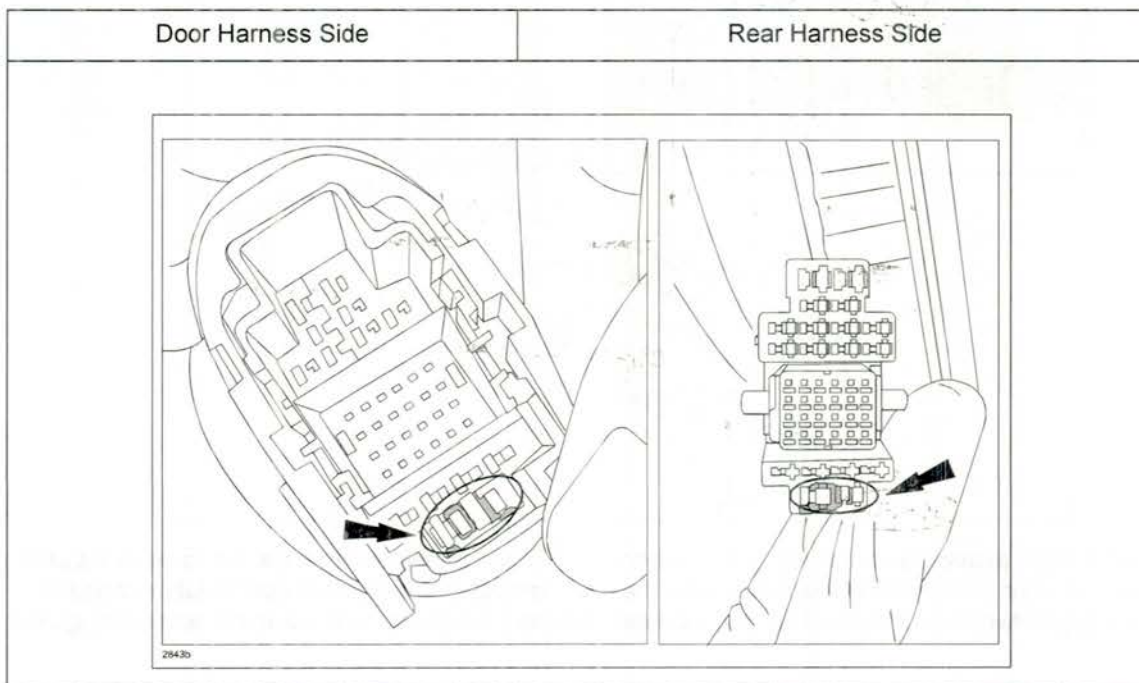
- If there is any corrosion at the C-15 connector, replace the door harness and repair the rear harness according to the following repair procedure.
 - If there is no corrosion found at the C-15 connector, this bulletin is not applicable. Troubleshoot the concern(s) according to the MS3 online instructions or the Workshop Manual.
1. Verify the customer concern.
 2. Record customers pre-set radio stations.
 3. Slide the driver side front seat fully backwards.
 4. Disconnect the negative battery cable.
 5. Disconnect the C-15 connector according to the MS3 online instructions or the Workshop Manual (section 09-11 FRONT DOOR REMOVAL/INSTALLATION).
 6. Inspect for any corrosion found on the terminals shown below.

- If there is any corrosion found on the terminals, go to next step.
 - If there is no corrosion found on the terminals, this bulletin is not applicable. Troubleshoot the concern(s) according to the MS3 online instructions or the Workshop Manual.
7. Remove the driver-side front side trim according to the MS3 online instructions or the Workshop Manual (section 09-17 FRONT SIDE TRIM REMOVAL/INSTALLATION).
 8. Remove the hood release lever from the under panel according to the MS3 online instructions or the Workshop Manual (section 09-14 HOOD LATCH AND RELEASE LEVER REMOVAL/INSTALLATION).
