Technical Bulletin

21 13 01 September 4, 2013 **2025464** Supersedes T. B. V211201 dated March 12, 2012 to include additional model year and Beetle, Beetle Convertible applicability.

Frozen Charge Air Cooler – Engine Will Not Start

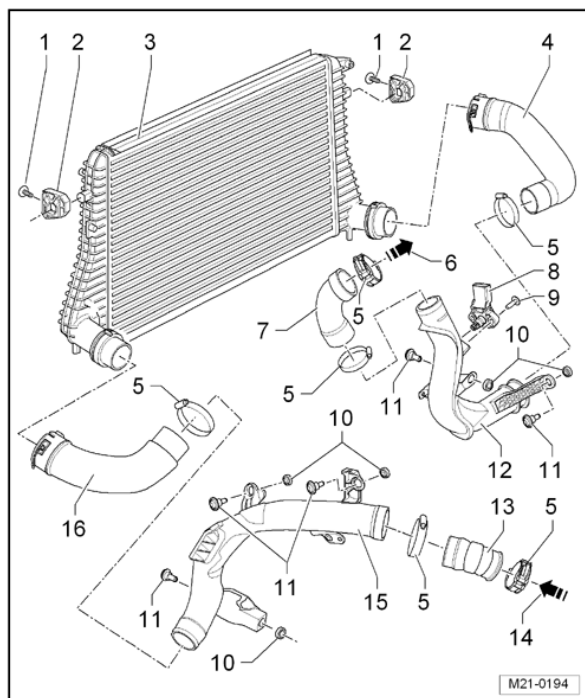
Figure 1

Engine will not start after standing in cold weather below 0°C (32°F), MIL may be illuminated with various induction and/or boost system faults stored in ECM.

Moisture from the intake air condenses and collects in the charge air cooler. At cold temperatures this moisture can freeze causing blockage of the intake air system.

Install revised charge air cooler kit P/N 1K0 198 803B to avoid the formation of this moisture in the boost system.

- Lock carrier in service position. See Repair Manual Group 50 in ElsaWeb.
- Separate A/C condenser from charge air cooler.
- Remove radiator and radiator fan assembly.
- Remove the original charge air cooler (item 3 in figure 1) from the vehicle.

- Remove the lower charge pressure hoses (items 4 and 16 in figure 1) and clean of any moisture or sludge. See Repair Manual Group 21, Turbocharger/G-Charger, Description and Operation, Component Overview, in ElsaWeb.
