SB-10055387-7764

Campaign No. 2013120001, December 2013

SUBJECT: **Model 207 (E-Coupe), Model Year 2013**
Rework Seam Seal at Left Tail Lamp

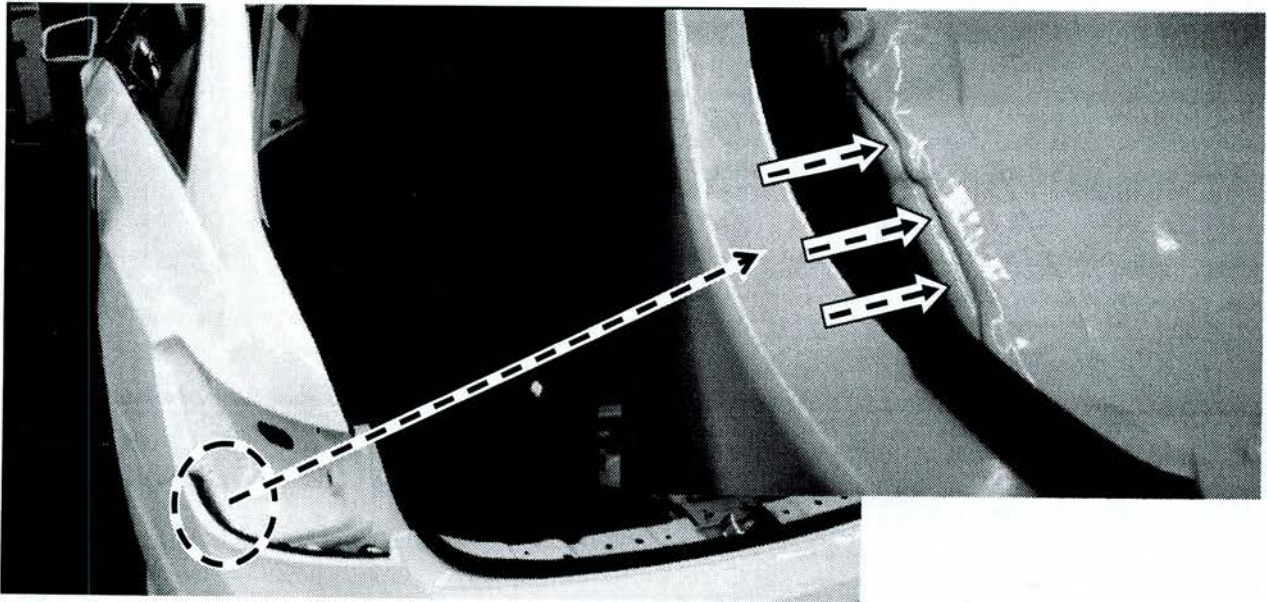
Figure 1

This Service Campaign has been initiated because Daimler AG (DAG), manufacturer of Mercedes-Benz vehicles, has determined that the seam seal at the left rear tail lamp may not be to specification possibly allowing moisture to enter the trunk. To correct this condition, an authorized Mercedes-Benz dealer will rework the seam seal at the left rear tail lamp at the next workshop visit.

- Be careful not to damage tail lamp seals when removing tail lamp.
2. Thoroughly clean seal seam and then degrease with silicone remover (shop supply).
 3. Apply missing sealant (arrows, Figure 1).
