Corrosion at electrical connecting point between front bumper and interior (X174/1) USA

Topic number	LI54.18-P-057840
Version	1
Design group	54.18 Cable harnesses
Date	12-04-2013
Validity	Model series 166
Reason for change	Distribution revised
Reason for block

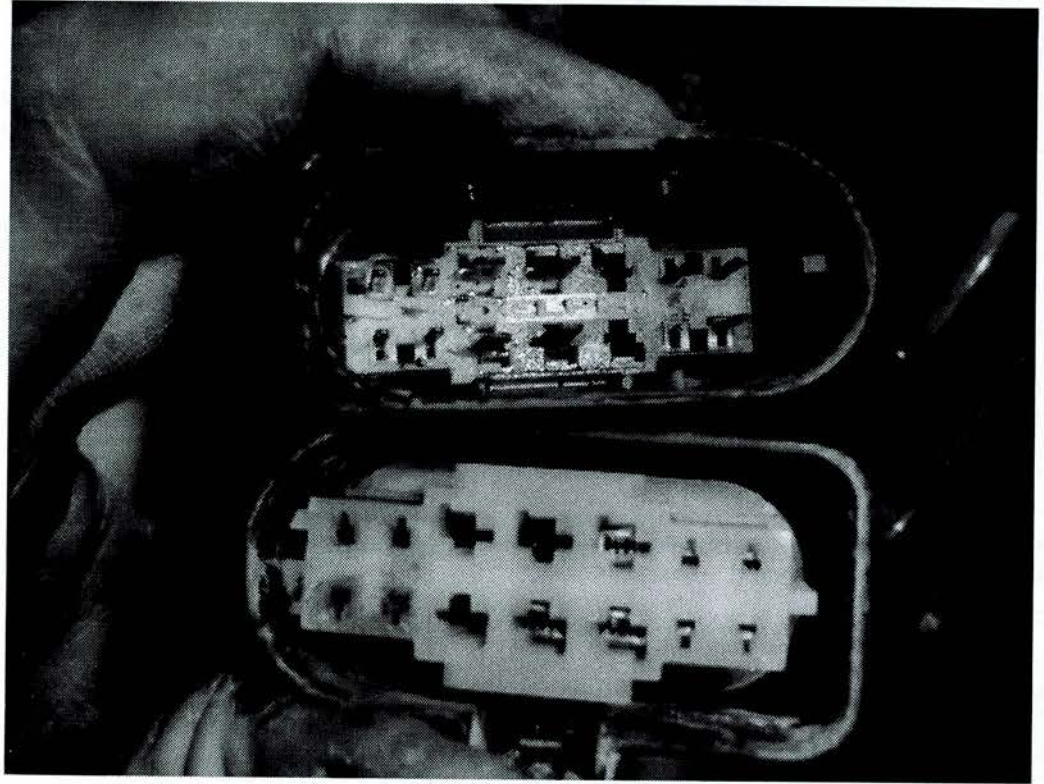
CIMG3906.JPG:

Corrosion may occur at the connecting point X174/1 from the front bumper to the interior wiring harness; see photo.

Attachments	
File	Designation
CIMG3906.JPG	Corrosion at connecting point X174/1

The root cause is to be identified. Please report the fault via a PTSS case, performing the following steps below. A remedy will be sent back to you to repair the vehicle.

- Picture of the position of where the connector is physically located in the vehicle.
- Pictures of the two sides fo the connector, vehicle side and bumper side.
- Check to see if the sealing plugs (blind plugs) are missing in the positions that are not used in the connector and note this in the case.
- Check to see if the connector fully seated together, and note this in the case.
