High Power Wall Connector Fuse Replacement

Classification	Repair Bulletin - Level I	Section/Group	50 - Vehicle Charging Systems	Country/Region	North America
Year	All	Model	Model S	Version	All

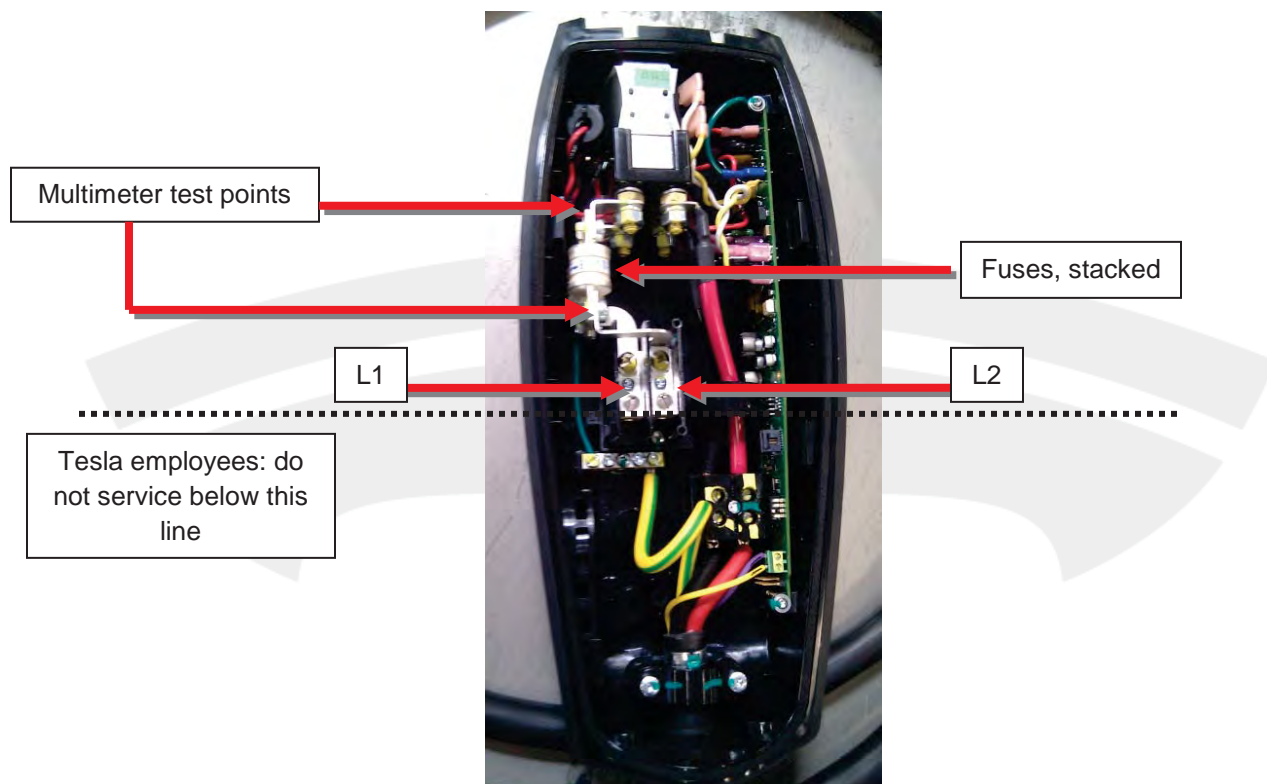
Figure 1 (Unit shown is not connected to house wiring)

5. Use a multimeter to check points on either side of each fuse and identify which fuse(s) failed (Figure 1). If neither fuse failed, stop this procedure and contact Engineering for support.

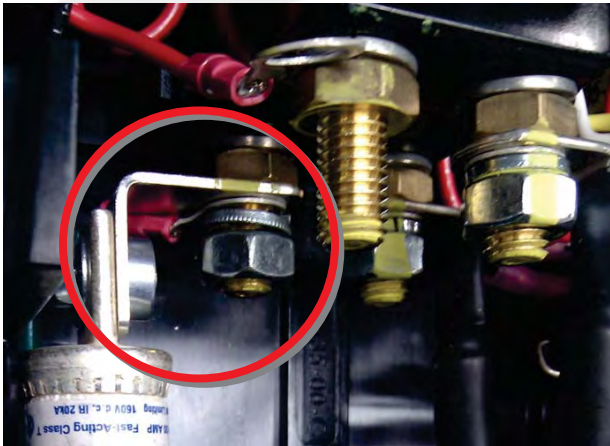
✓ Figure 7 (Correct)

⚠ CAUTION: Always install the bus bar first and the ring lug second. Installing the ring lug first can result in excessive resistance and overheating (Figures 7 and 8).

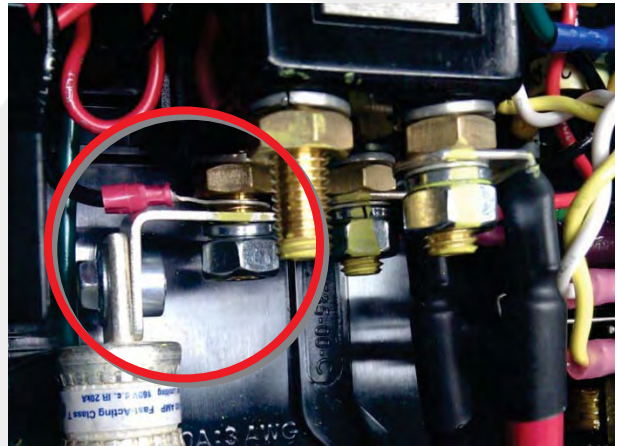
✗ Figure 8 (Incorrect)

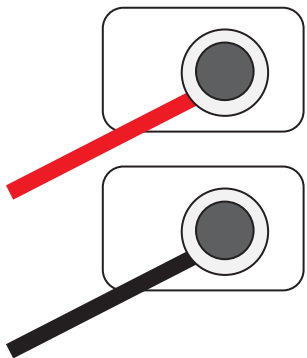
✓ Figure 9 (Correct)

⚠ CAUTION: Always clock both ring lugs so that the wires point toward the back of the unit at a 45-degree angle, allowing a gap between the top wire and the bottom bus bar (Figures 9 and 10). Wires must not rest on the bus bars (Figures 11 and 12).

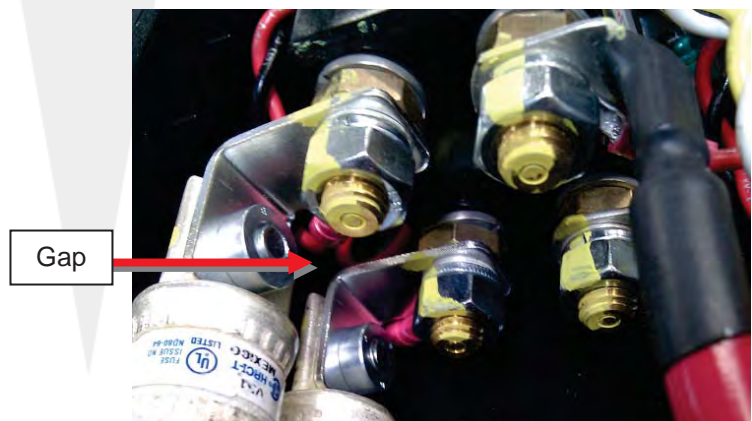
✓ Figure 10 (Correct)

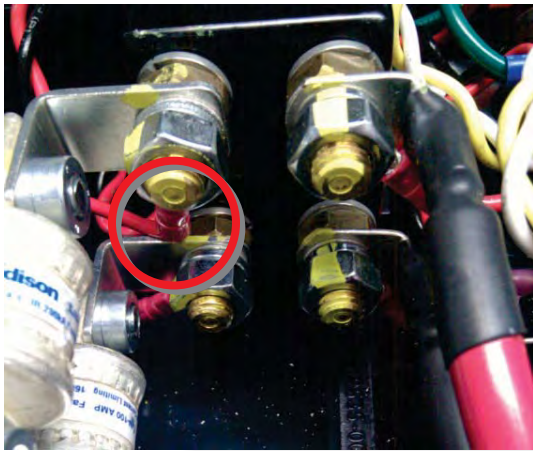
✗ Figure 11 (Incorrect: resting on bus bar)

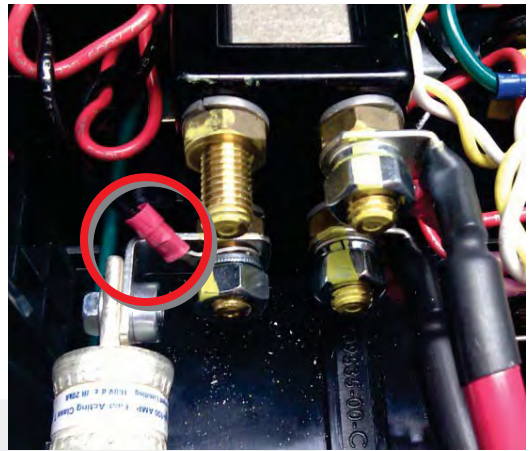
✗ Figure 12 (Incorrect: wire in front of bus bar)
