Topic	Continental range and Flying Spur - Steering wheel found misaligned during pre delivery inspection road test
Market area	Worldwide Bentley (1WBE)
Brand	Bentley
Transaction No.	2026285/4
Level	EH
Status	Approval
Release date

Transaction No.: 2026285/4

Continental range and Flying Spur - Steering wheel found misaligned during pre delivery inspection road test

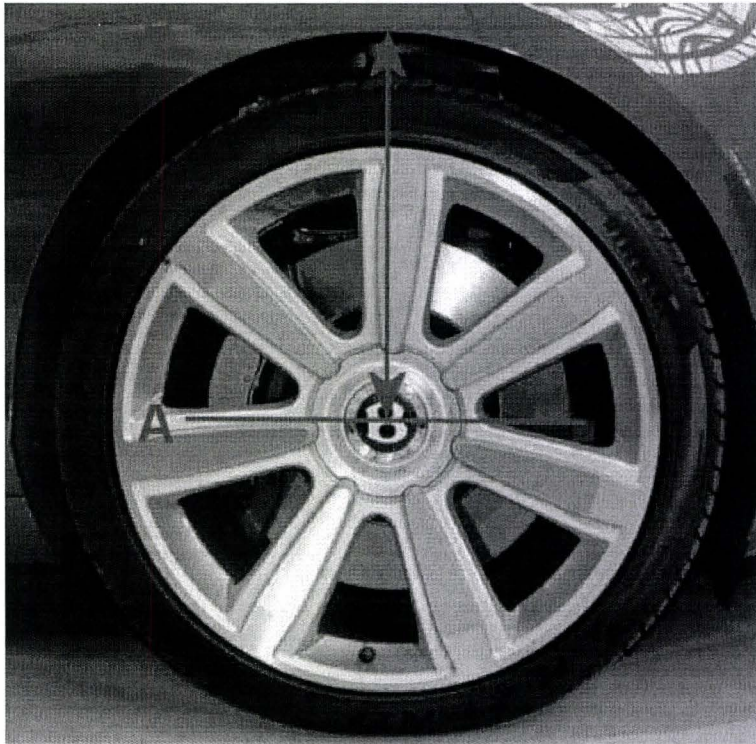
Figure 1

1. With the vehicle parked on a flat and even surface measure from the centre of each wheel (Figure 1 point A) to the lowest edge of the wheel arch (Figure 1 point B) record all measurements in mm

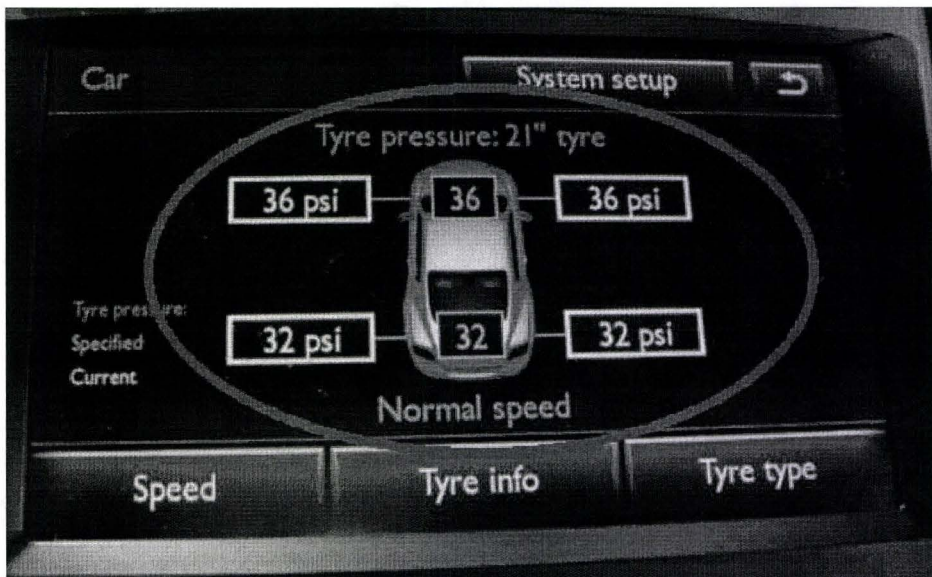
2. Using the Infotainment unit check and record all four tyre pressures, Figure 2 shows the Infotainment screen fitted in 12 Model year vehicles

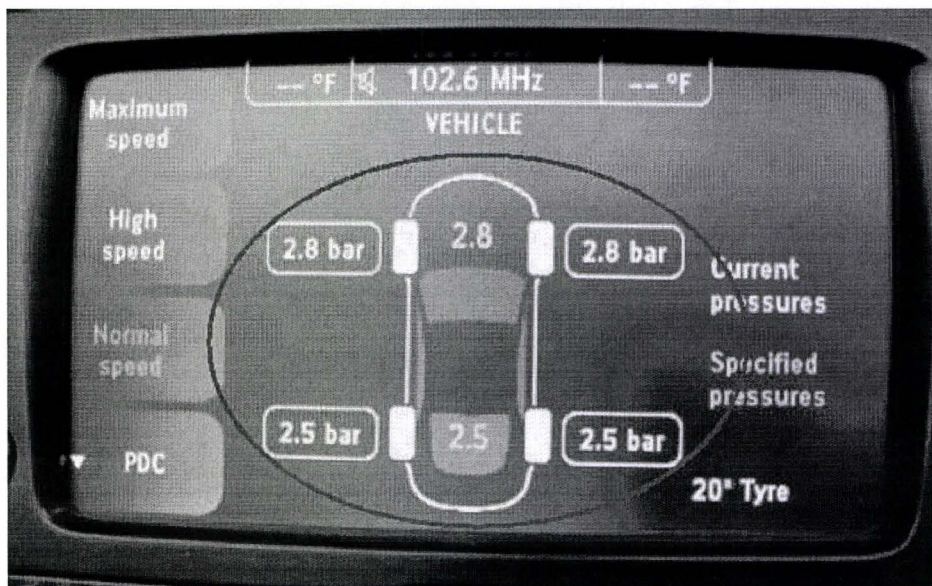
Figure 3 shows the infotainment screen fitted in 2011 Model Year vehicles

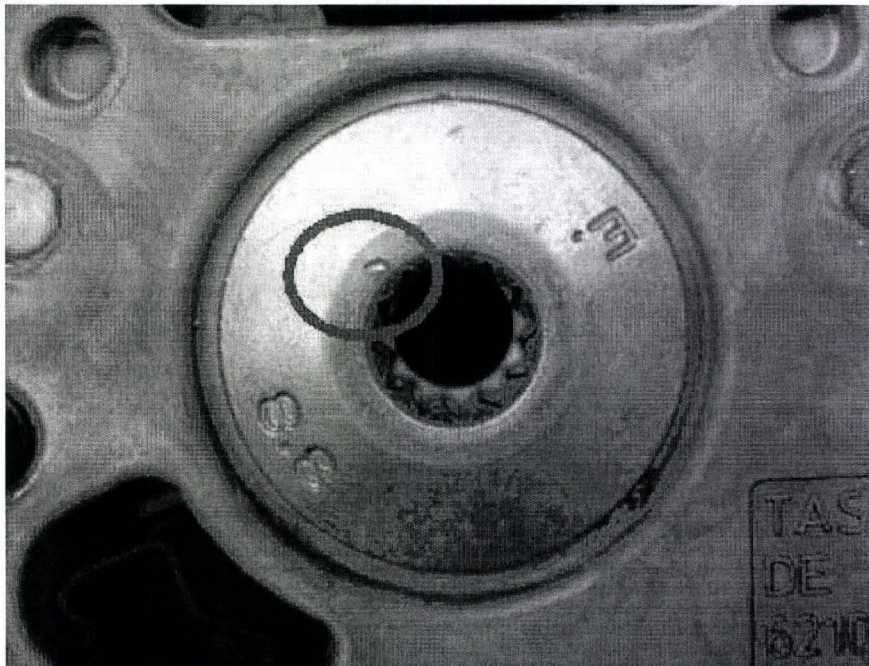
Figure 4

4. Are there any dot punch indentations on the steering wheel securing bolt (Figure 4) indicating that the steering wheel has been previously removed?

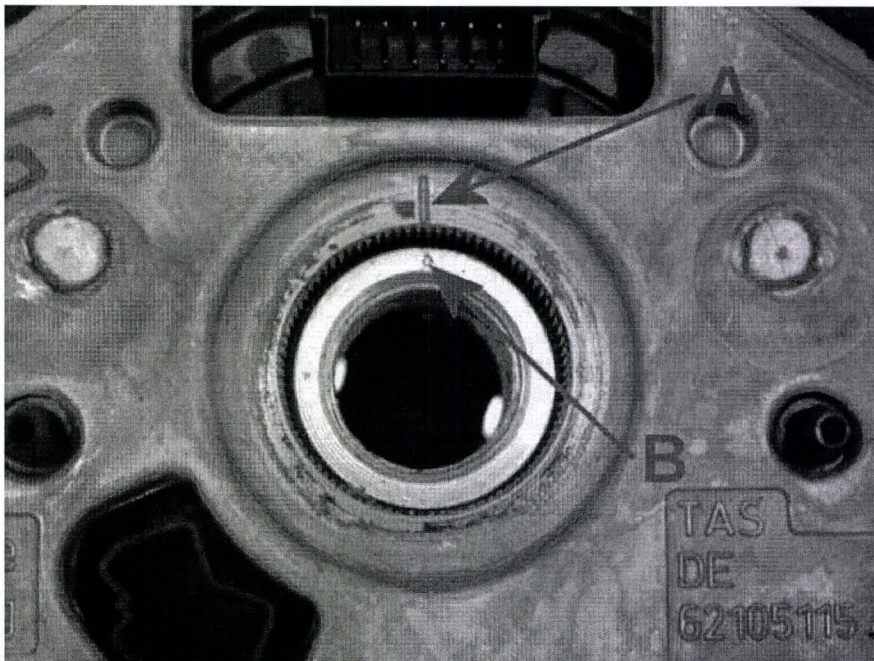
Figure 5

6. Check the timing line on the steering wheel (Figure 5A) is aligned with the dot punch on the steering column (Figure 5B)

Is the steering wheel timing mark aligned with the steering column dot punch? Tick the appropriate box

If NO the steering wheel should be aligned go to **SECTION 2**

8. Refit the steering wheel ensuring the timing line on the steering wheel is aligned with the dot punch on the steering column (Refer to Figure 5), Refer to workshop manual Rep Gr 48 Steering Wheel – To Remove and Fit

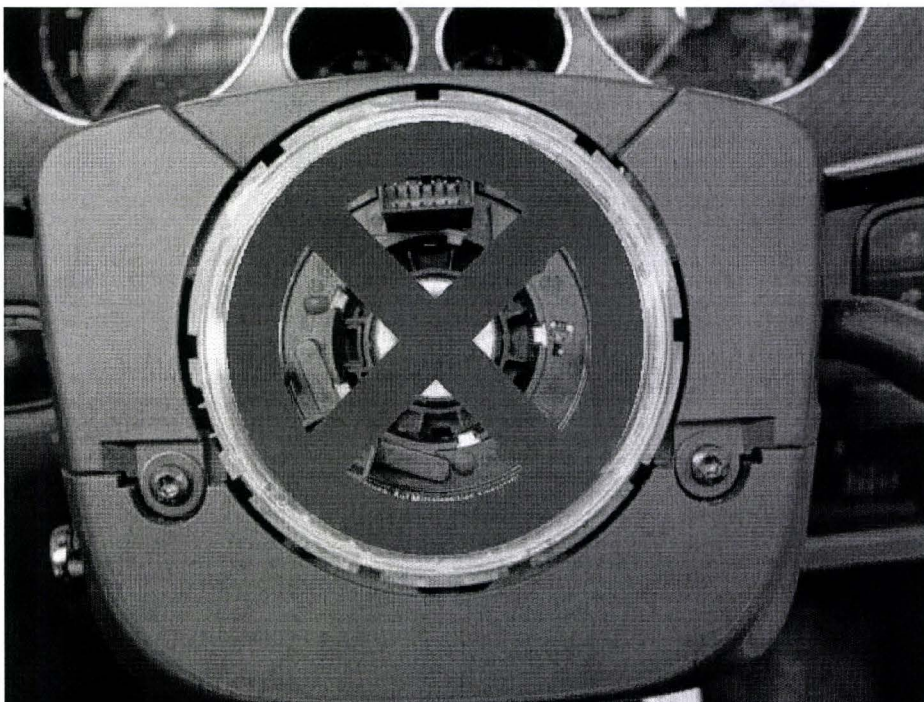
Figure 7

Whilst the steering wheel is briefly removed for realignment DO NOT under any circumstances move or turn any part within the zone in Figure 7, the multi function switch ribbon cable can be damaged, leading to the possible replacement of the multi function switch
