Topic	RE13/14 Carbon ceramic brakes Continental family
Market area	Worldwide Bentley (1WBE)
Brand	Bentley
Transaction No.	2030329/1
Campaign number	R790
Note	
Type	Recall campaign
US code

Recall campaign R790

RE13/14 Carbon ceramic brakes Continental family

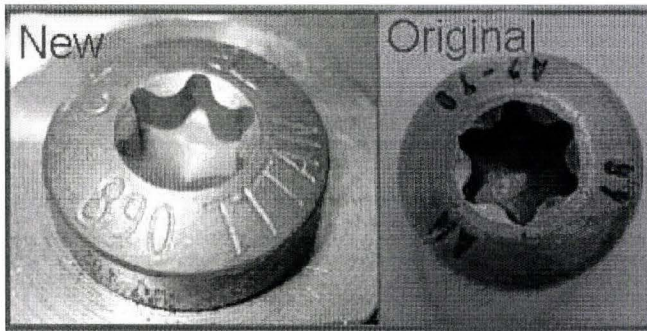
Figure 1

1. If the vehicle is not already listed as repaired in the "Repair history" (in ElsaPro), check the disc retaining bolts on the vehicle. If the brake discs are already secured with bolts identified as "New" in figure 1 then this document is not applicable. If any disc securing bolts are identified as "Original" as shown in figure 1 then carry out the required work in accordance with these instructions. Note: Due to previous service work it is feasible that a car may have one disc secured with "Original" bolts and another disc secured with the "New" bolts in this instance only replace the bolts where the old "Original" bolt is present.

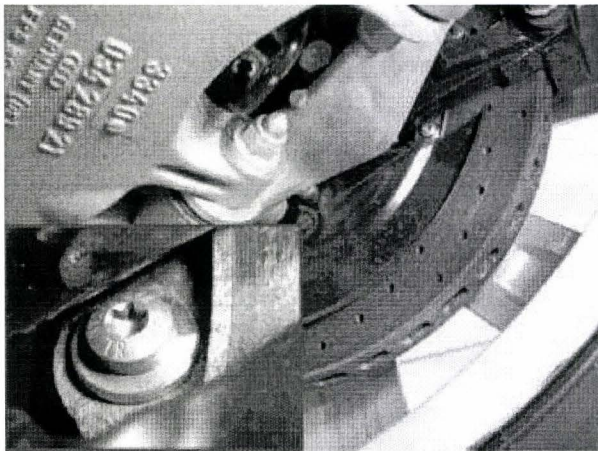
Rear

The rear disc retaining bolt can be viewed from inside the wheel. The front is checked through the wheel spokes

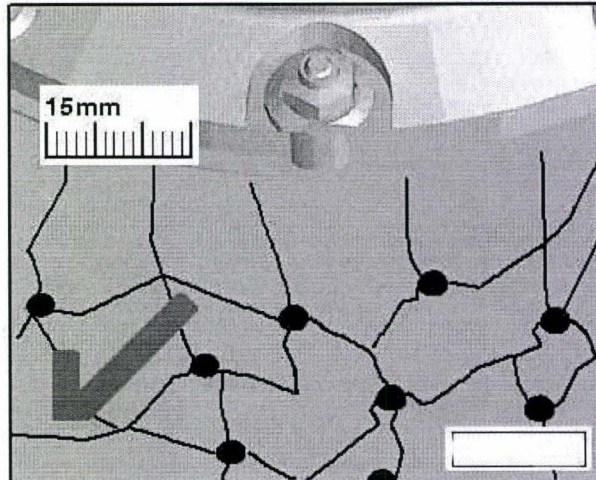
Due to the production process, relaxation cracks already exist on the friction surface of the brake disc when it is new. These cracks can vary in size and can occur on both sides of the disc.

Relaxation cracks on a ceramic brake disc do not constitute a technical problem.

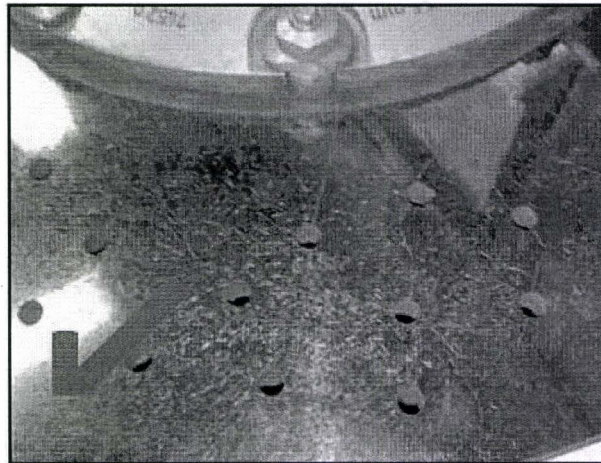
Cracks in the cooling channel lands -arrow- are caused during manufacture.

Cracks in the cooling channel lands do not constitute a technical problem.

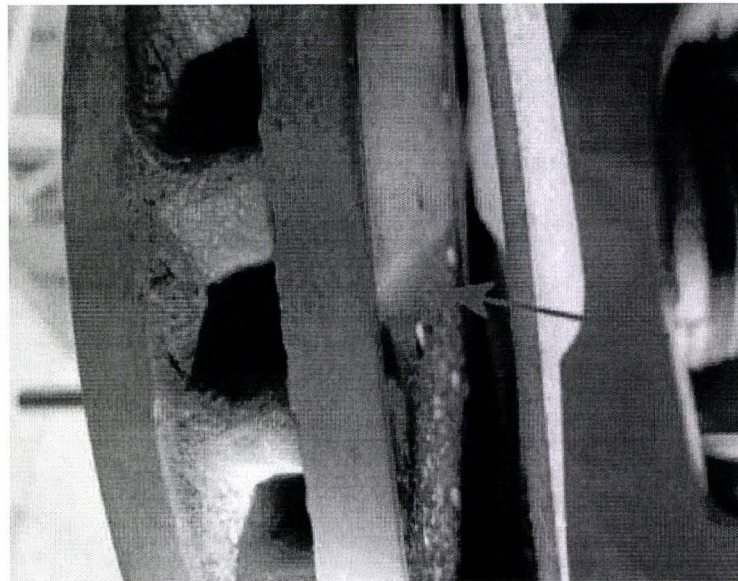
must be replaced if there are cracks in the vicinity of the bolted connection on the **inside** of the brake disc hub extending into the friction surface of the disc - arrows-

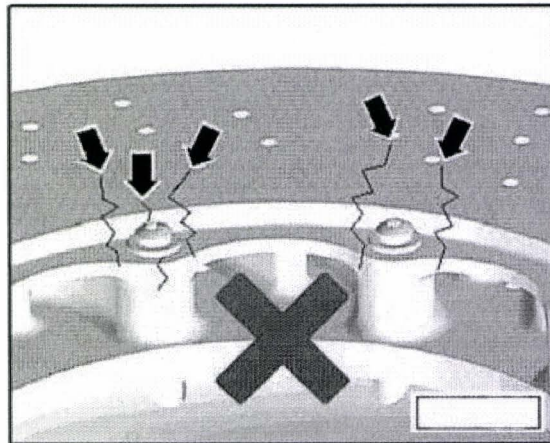
Ceramic brake discs must be replaced if there are radial cracks in the area of the bolted connection on the brake disc hub.

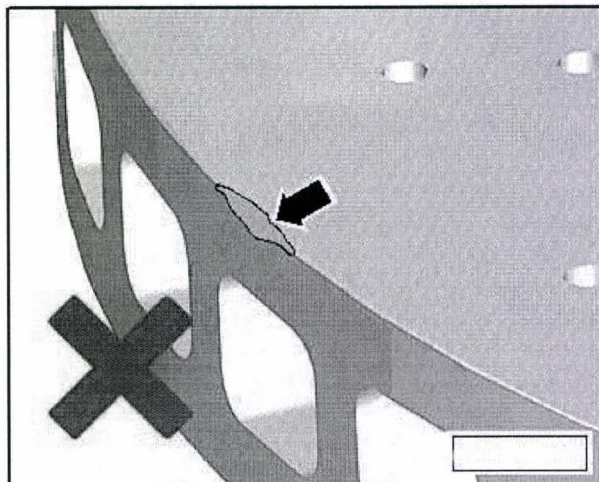
Edge fractures - arrow- are caused by mechanical

damage to the edges of the disc.

- Max. width / depth = 2 mm
- Max. length = 10 mm
- Max. 3 edge fractures per brake disc

If any of the criteria listed above are exceeded, the brake disc must be replaced.

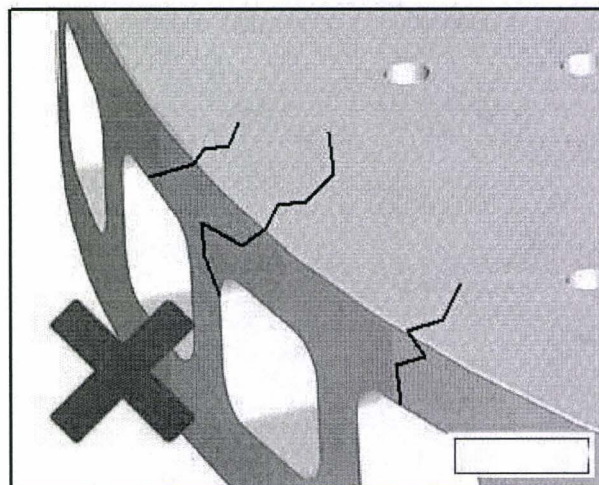
Ceramic brake discs with cracking extending from the friction surface of the disc to the cooling channel or through the cooling channel must be replaced.

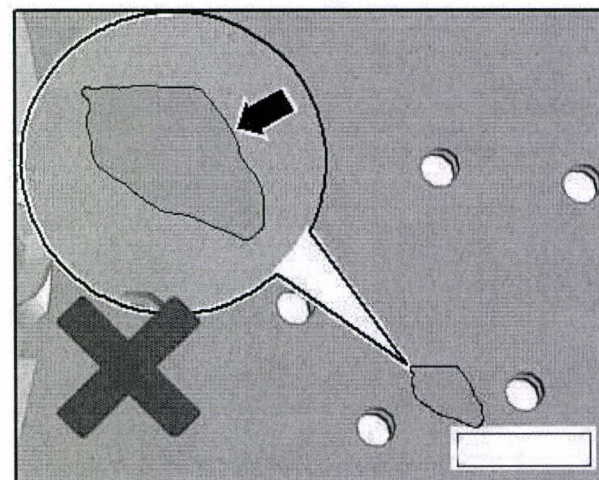
Ceramic brake discs with chipping larger than 1 cm² at any one point -arrow- on the friction surface must be replaced.
