Field campaign

Topic	Mulsanne side view camera control module (SC12/15)
Market area	Worldwide Bentley (1WBE)
Brand	Bentley
Transaction No.	2030874/3
Campaign number	E775
Note	E775
Type	
US code

Mulsanne

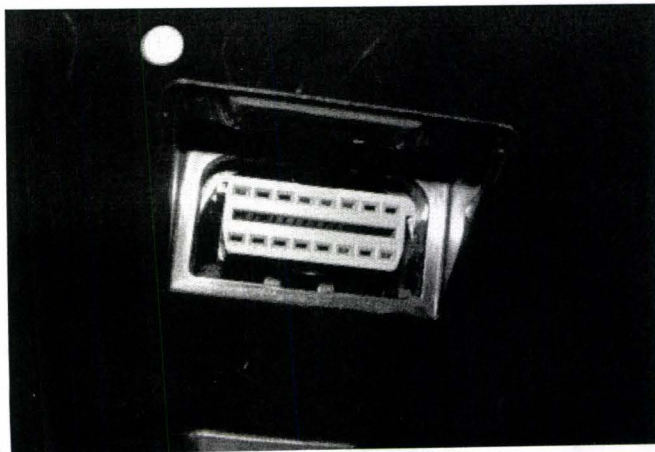
Figure 2

If the vehicle is not already listed as repaired in "Repair history" (in Elsa pro), check for the Campaign completion identification mark which is a White paint mark located above the diagnostic plug cover (Figure 2) the White mark confirms the latest specification part has been fitted, should neither be evident carry out the required work in accordance with instructions.

White paint mark on the diagnostic plug surrounding cover confirms the latest specification part has been fitted.

3. Should the original side view camera control module have been previously removed and replaced with the link loom 3Y0 998 381 there should be a Yellow completion paint mark on the diagnostic plug surrounding cover (Figure 1), please carefully remove this and replace with a White paint completion mark as shown in Figure 2. If the original control module has been replaced for the latest specification part or the factory fitted loom has been replaced with the latest specification part, a White paint completion mark should also be added (Figure 2)
