| <b>Topic</b> | Convertible roof - C flap Bowden cable replacement |
| <b>Transaction No.</b> | 2033467/1 |

Convertible roof - C flap Bowden cable replacement

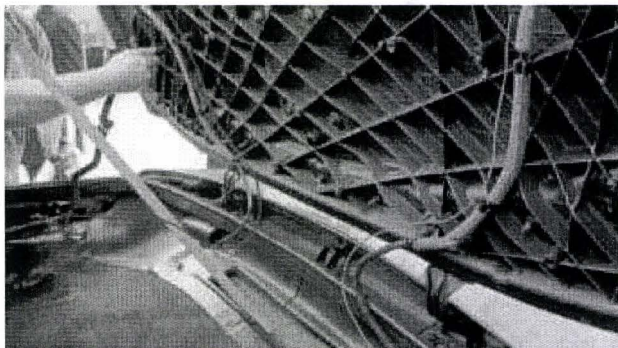
Continual improvement in system designs can produce developments that may benefit older vehicles. One such development has been identified in the convertible roof mechanism. Re-route the C flap Bowden cable using a longer cable reduces the friction build up in the system and thus promotes smooth operation of the C flap and longevity in the system

Figure 1 depicts the original routing of the Bowden cables. Note the sharp radius of the Bowden cable and the multiple clips securing the cable to the tonneau cover all these contribute to the increased friction in the system. The new arrangement removes the sharp radius and deletes all but one of the clips securing each cable to the tonneau cover

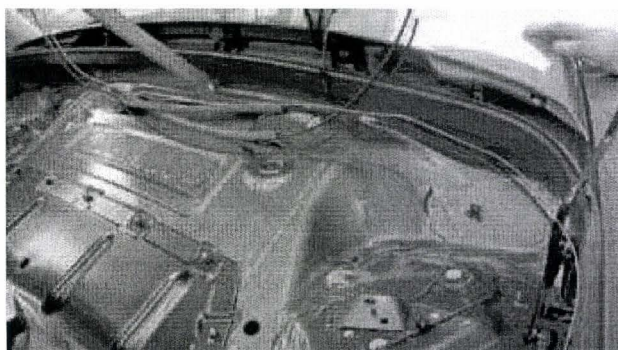
Figure 2 depicts the new longer cables following the cross over routing
