Technical product information

Transaction No.: 2033480/2

Gear range selector inoperative

Release date: 11-Sep-2013

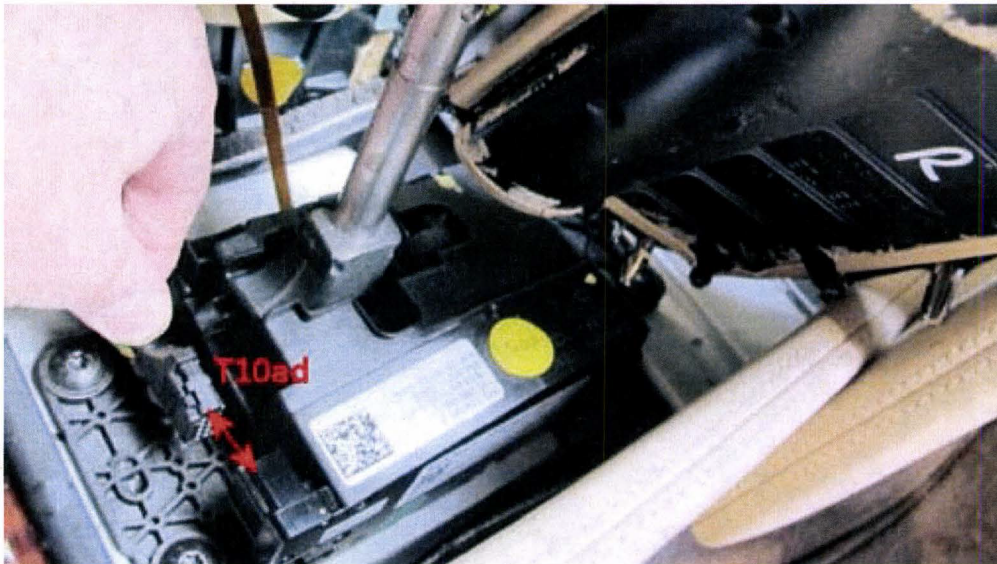
Figure 1

To disconnect/reconnect the gear selector electronics disconnect the 10 way connector (connector T10ad in current flow diagrams) at the gear selector assembly (see Figure 1)

2. Pull the switch pack upwards from the rear edge
3. Disconnect the harness connector arrowed – from the rear of the switch pack  
**Note:** as long as the ribbon cable is not strained it can remain connected for this operation
4. Disconnect and reconnect connector T10ad (see Figure 1)  
 Communication should now be possible - Clear the event memory entries - Test the gear selection function and re-assemble
