<b>Topic</b>	Convertible roof – revised clip arrangement - C flap Bowden cable (SC13/12)
<b>Market area</b>	Worldwide Bentley (1WBE)
<b>Brand</b>	Bentley
<b>Transaction No.</b>	2033508/1
<b>Campaign number</b>	E788
<b>Note</b>	
<b>Type</b>	
<b>US code</b>

E788

Transaction No.: 2033508/1

Convertible roof – revised clip arrangement - C flap Bowden cable (SC13/12)

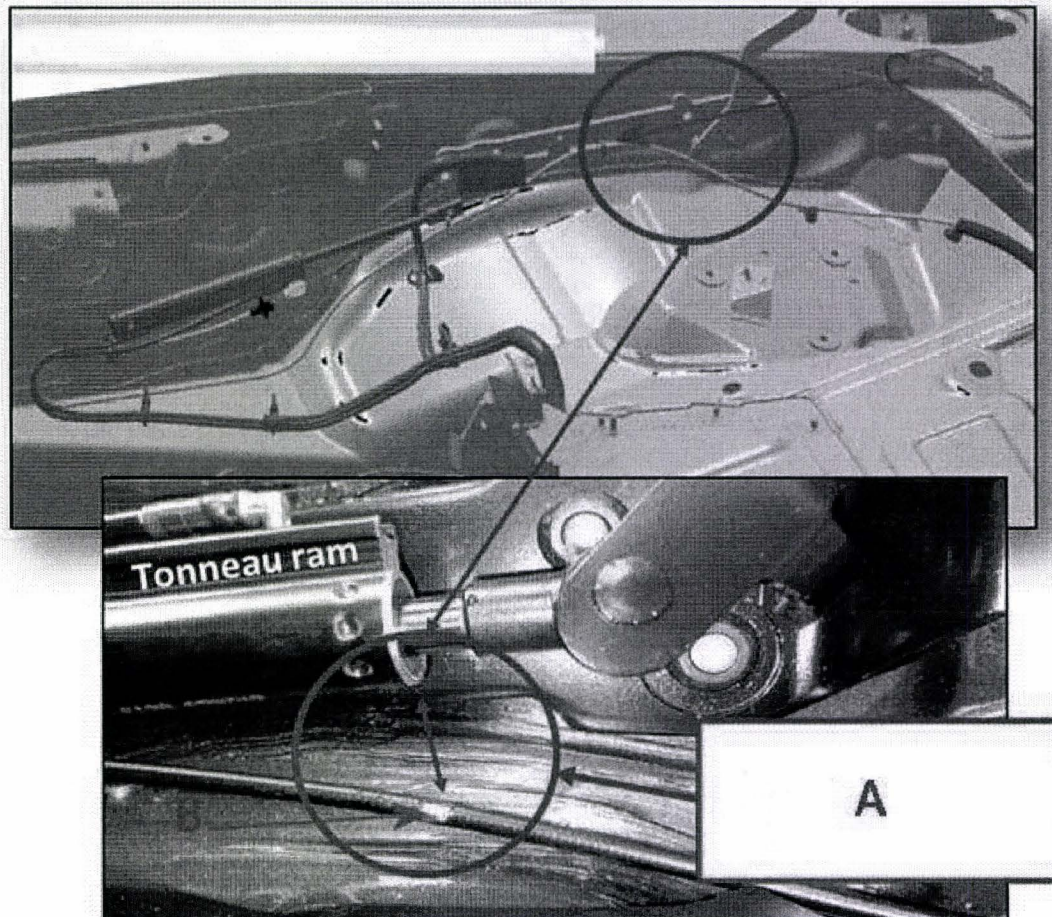
A potential compression point has been identified between the tonneau cover hydraulic ram and the C flap Bowden cable as it routes under the tonneau cover drive system (see Figure 1). A revised clip arrangement has been specified to avoid this compression damage. In severe cases the damage to the Bowden cable is such as to impair correct operation of the C flap, therefore a test of the C flap function is required to ensure the Bowden cables are serviceable before implementing the revised clip arrangement

- Figure 1 details the original routing and single cable tie (C) securing the Bowden cable (shown in yellow). The detail at point A shows the potential contact point between the tonneau cover hydraulic ram and the Bowden cable. The actual contact takes place when the tonneau is almost closed and therefore the close proximity of the hydraulic ram and the Bowden cable cannot be seen when viewed with the tonneau cover in a transient position. Detail B shows, in this case, a section of the outer sheath of the Bowden cable that has been removed by repeated contact with the ram.

Note: as long as the system has passed the C flap function test then the absence of some of the outer sheathe is not sufficient grounds to change the cables

All affected vehicles require a C flap function check to ensure correct operation before either applying the revised clip arrangement or in the case of failed function test refer to TPI 2033467 C flap Bowden cable replacement

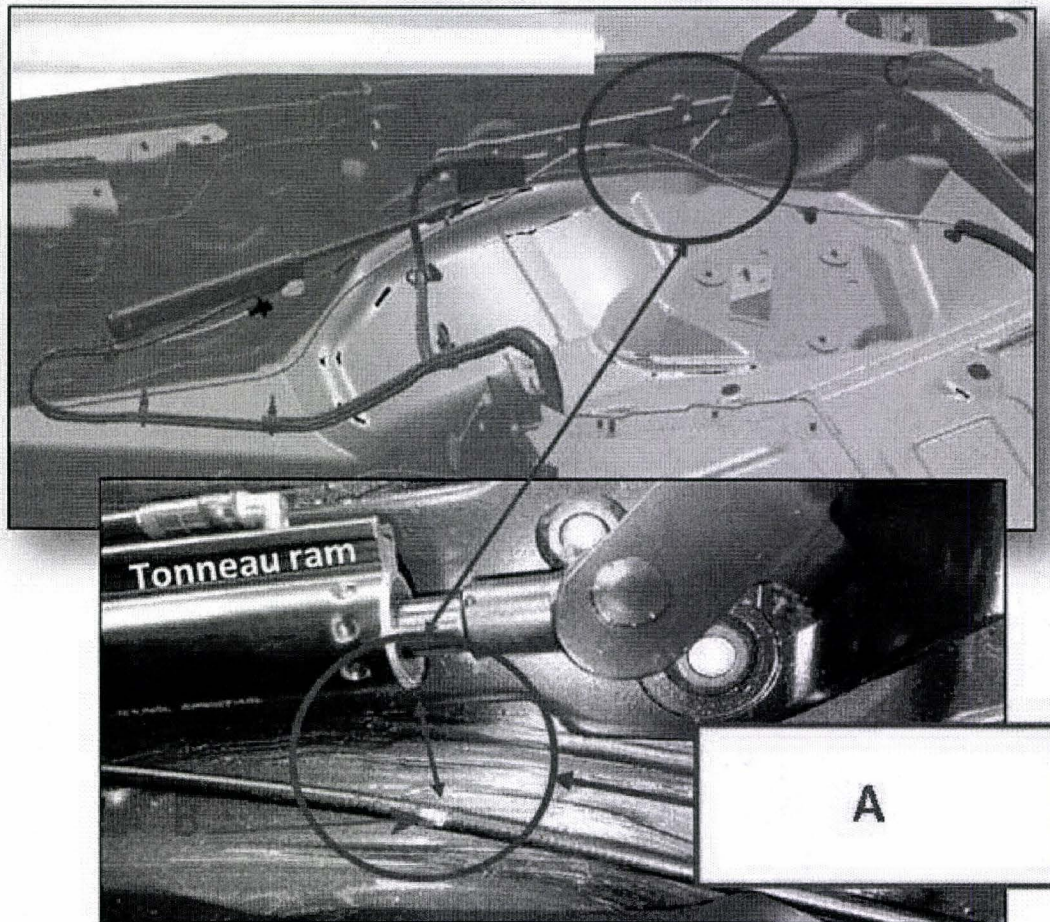
A potential compression point has been identified between the tonneau cover hydraulic ram and the C flap Bowden cable as it routes under the tonneau cover drive system (see Figure 1). A revised clip arrangement has been specified to avoid this compression damage. In severe cases the damage to the Bowden cable is such as to impair correct operation of the C flap, therefore a test of the C flap function is required to ensure the Bowden cables are serviceable before implementing the revised clip arrangement

1. Figure 1 details the original routing and single cable tie (C) securing the Bowden cable (shown in yellow). The detail at point A shows the potential contact point between the tonneau cover hydraulic ram and the Bowden cable. The actual contact takes place when the tonneau is almost closed and therefore the close proximity of the hydraulic ram and the Bowden cable cannot be seen when viewed with the tonneau cover in a transient position. Detail B shows, in this case, a section of the outer sheath of the Bowden cable that has been removed by repeated contact with the ram. Note: as long as the system has passed the C flap function test then the absence of some of the outer sheath is not sufficient grounds to change the cables

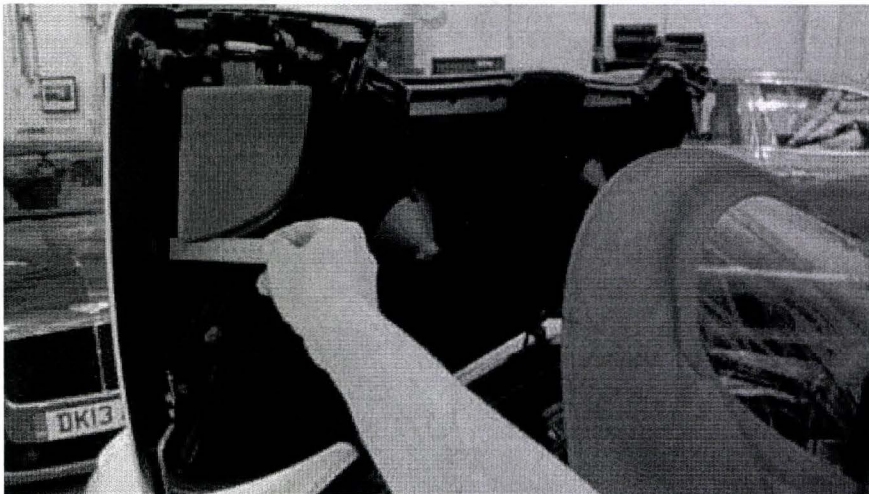
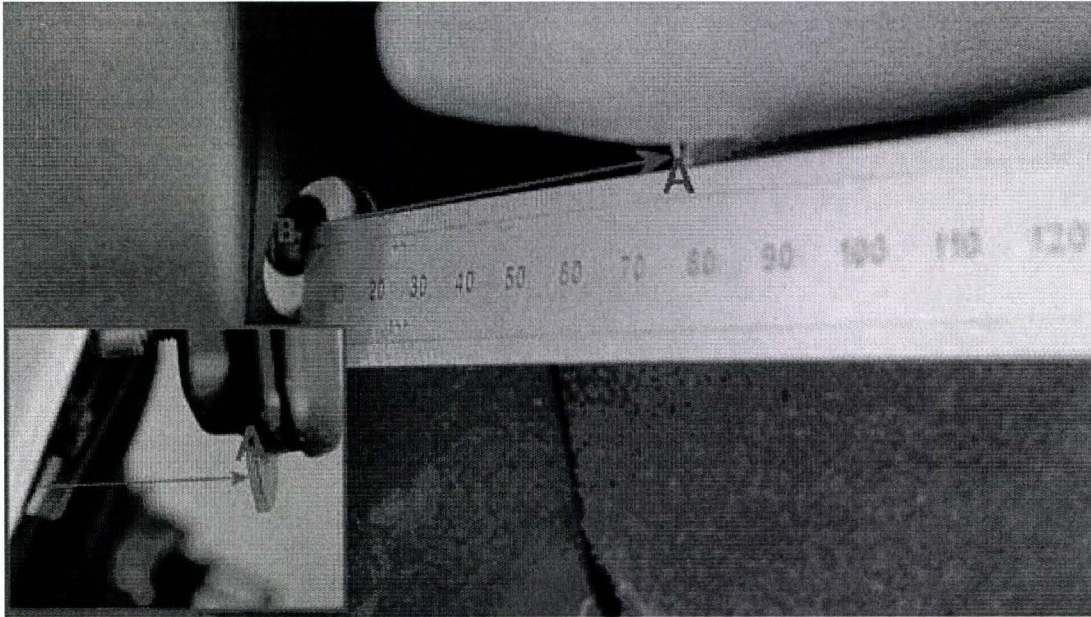
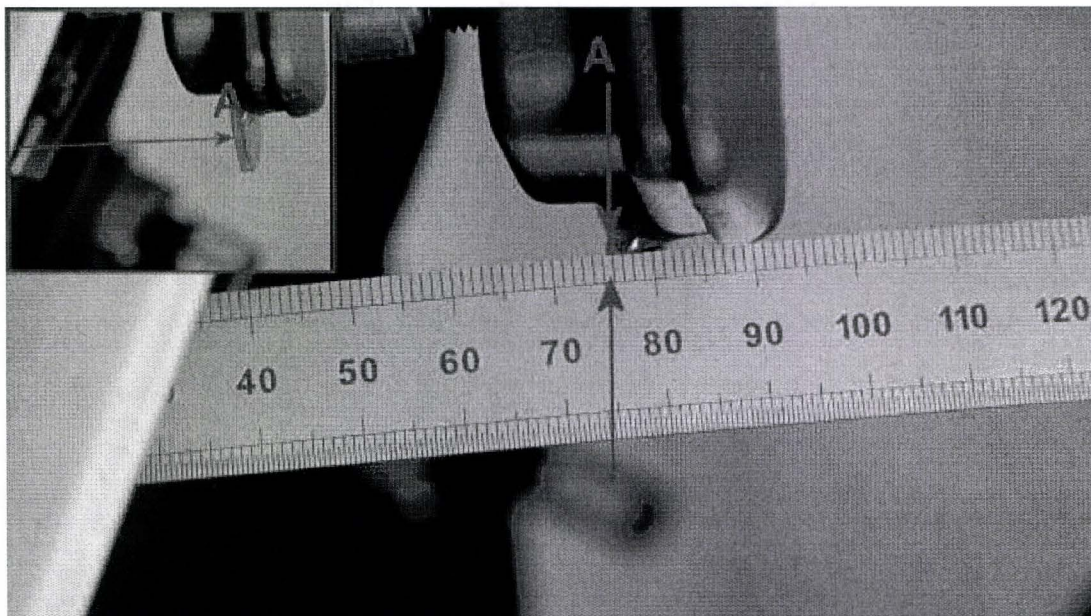
5. Referencing figures 3, 4 and 5 take a measurement between point (A), C flap obscuration lip, and (B), tonneau brightware securing bolt head. The correct specification for this measurement is 74mm to 90mm. If this measurement is not to specification or the C flaps are out of synchronisation or judder during operation then refer to TPI 2033467 to carry out C flap Bowden cable replacement. If the C flap is to specification then perform the revised clip arrangement
