Technical product information

Topic	Continental range power boot close switch - correct diagnosis
Market area	Worldwide Bentley (1WBE)
Brand	Bentley
Transaction No.	2033745/1
Level	EH
Status	Approval
Release date

Transaction No.: 2033745/1

Continental range power boot close switch - correct diagnosis

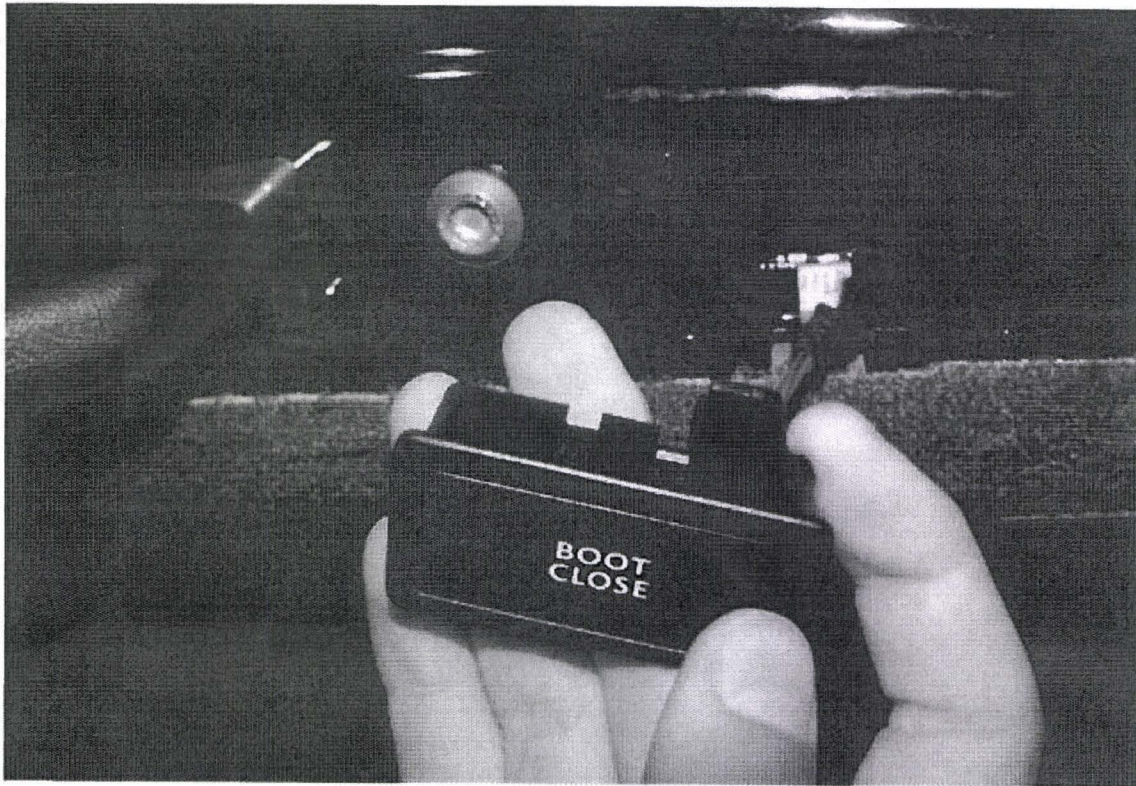
Figure 2

-With the boot close switch hanging in free air press the switch to check if the boot lid starts to close, should this be the case and the boot lid starts to close the switch is serviceable, you should now proceed with procedure 6 **NOTE:** should the boot not start to close proceed to procedure 5

4.Reconnect the switch to the electrical connection (Figure 2) allowing the switch to hang in free air

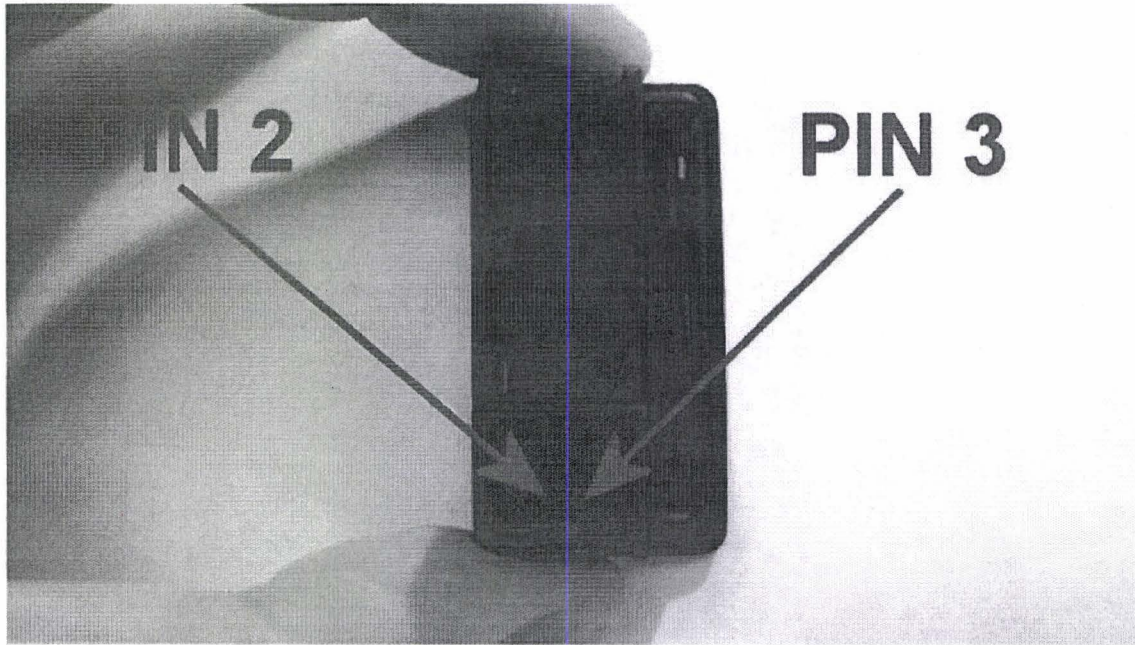
Figure 3

The resistance for a fully serviceable switch when operated (pressed) is 0.2 Ohms

- Measure the resistance between pins 2 and 3 (Figure 3) The button on the boot close switch must be pressed and held in otherwise a correct reading will not be obtained

IMPORTANT: The measurement should now be recorded in the warranty claim comments box when claiming for a new switch.
