Topic	Continental GT and GTC boot lid adjustments
Market area	Worldwide Bentley (1WBE)
Brand	Bentley
Transaction No.	2033742/1
Level	EH
Status	Approval
Release date

Transaction No.: 2033742/1

Continental GT and GTC boot lid adjustments

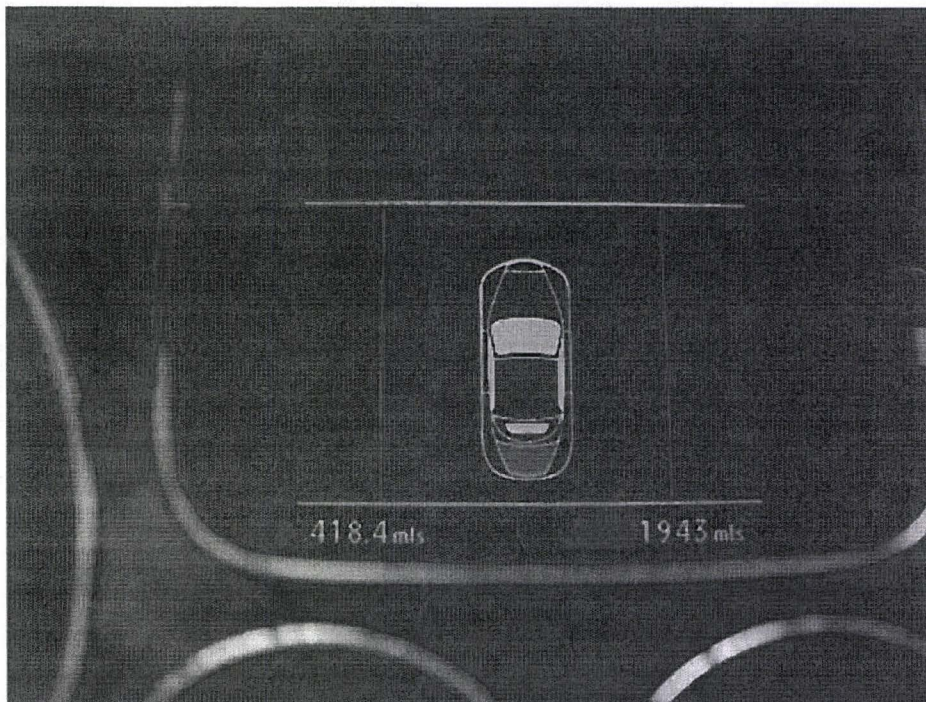
Figure 1

- Section 1 should only be applied if the boot lid fails to latch
- Section 2 is applicable to Continental GTC vehicles only, which exhibit the following symptoms:
 - The boot lid is fully latched however the boot open warning light is still illuminated in the DIP (Figure 1) or the boot latches and re-opens, the process in Section 2 describes how to adjust the boot lid overload switch.

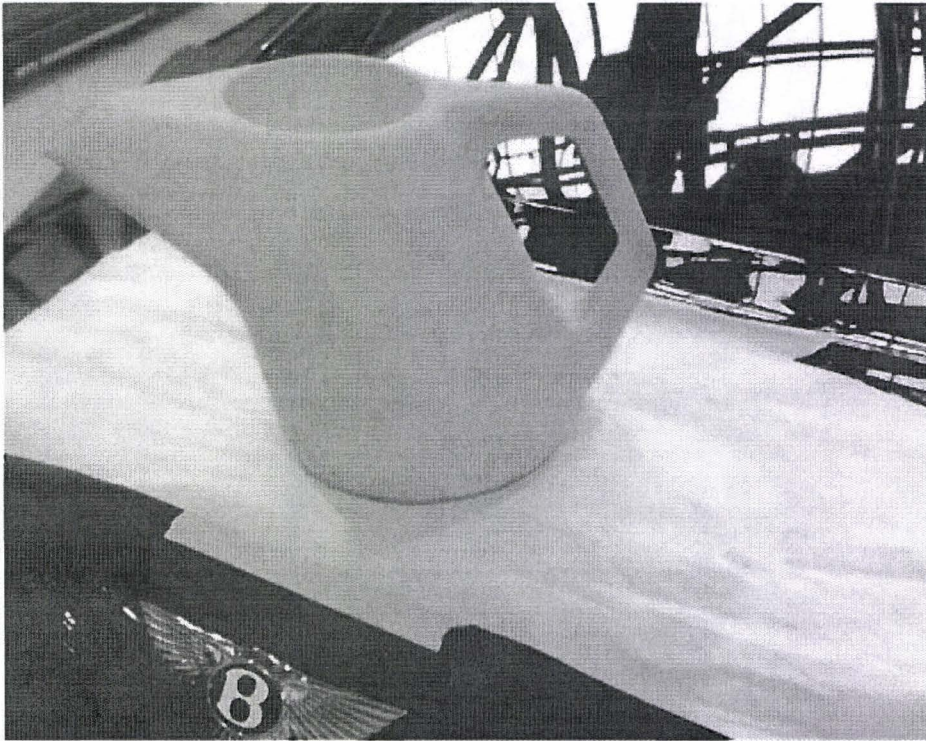
Figure 2

-Open the boot lid and then manually lower the boot lid until it rests on the first point of resistance usually the (seal/striker) rest a 2 Kg weight (2 litres of water as shown in Figure 2) on the boot lid above the latch having first protected the paintwork

-If the boot does not latch with the 2Kg weight there is an excess of mechanical resistance in the system. The following procedures explain how to reduce it to achieve power boot close to latch

-If on application of the 2Kg weight the boot closes, this indicates there is no excessive mechanical resistance in the system, therefore the fault will be elsewhere and the procedures within Section 1 of this TPI do not apply

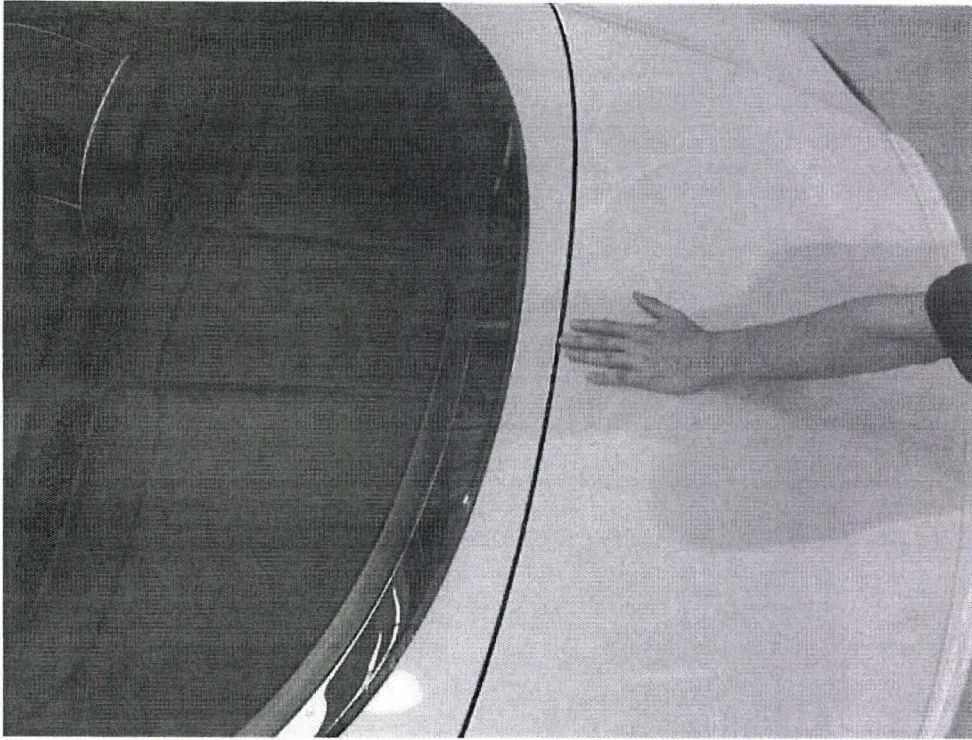
Figure 5

1. Check if the warning in the DIP extinguishes when light downward pressure is applied to the centre foremost part of the boot lid (Figure 5) take extreme care not to damage the boot lid

- If the light extinguishes this indicates the overload switch has activated
- The overload switch should be adjusted with the boot closed and the hood is fully stowed positioned the tonneau cover in the service position (Figure 6)
