Technical product information

Transaction No.: 2034036/1

Multimedia operating controls - sticking

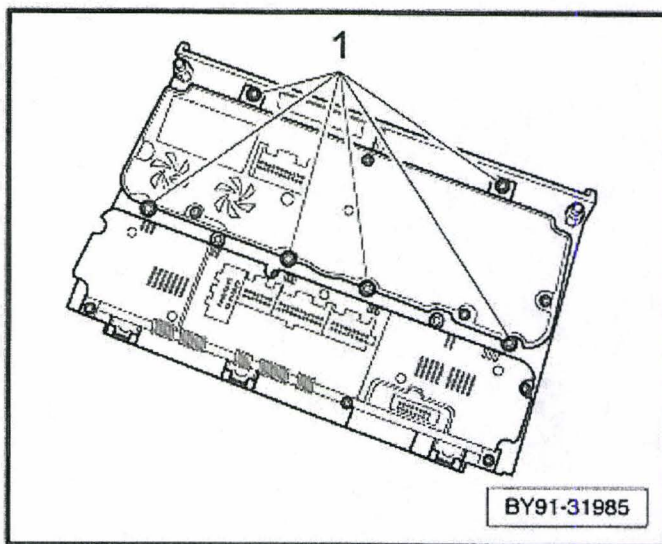
Figure 1

Push button switches or rotary control (haptic knob) for infotainment system sticks

A number of multimedia operating units have been replaced in warranty and subsequently when tested found to be without fault. It has been identified that a slight torsional load can cause the push button switches or haptic knob to stick. When this is the case a minor positional adjustment of the fascia in relation to the multimedia operating unit can be sufficient to stop the buttons from sticking

On the occasion that the multimedia operating unit is removed (Rep. Gr.91) for the purpose of replacement for sticking buttons or haptic knob then slacken the six screws (see Figure 1) and retighten to 1.7Nm then retest. If any function is still suspect then continue with your initial diagnosis and fit a replacement unit
