| <b>Topic</b> | Radio unit replacement - water ingress check |
| <b>Transaction No.</b> | 2034119/1 |

Radio unit replacement - water ingress check

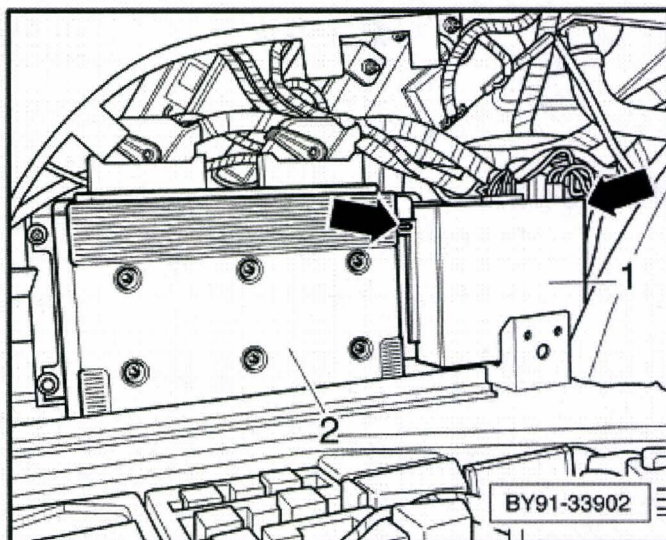
Figure 1

The radio unit fitted to Mulsanne is located in the left hand rear wing (see Figure 1)

Quality control inspection carried out on returned failed radio units has revealed evidence of water damage on some internal components

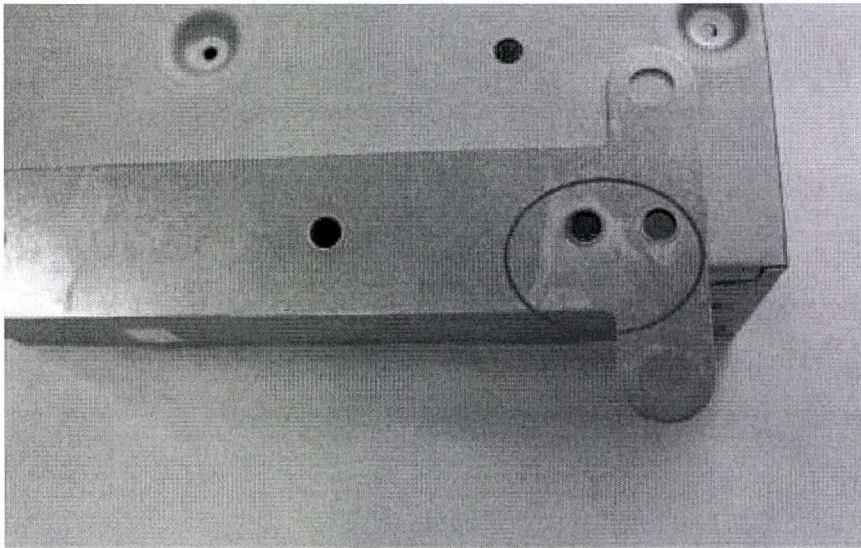
Figure 2

On the occurrence that a radio unit is removed for incorrect operation inspect the outside of the unit for evidence of water contamination. The evidence may be subtle therefore a close inspection may be required see figures 2 and 3. If water contamination is evident then the root cause of the leak must be identified and rectified before fitting a replacement radio unit.

When performing a water leak test ensure the fuel filler spill drain tube is checked as part of the test. This is located inside the fuel filler bowl
