Subject: MIL ON WITH DTC P2610	Bulletin No: 01-001/13
	Last Issued: 01/16/2013

2014 Mazda6

2013-2014 CX-5

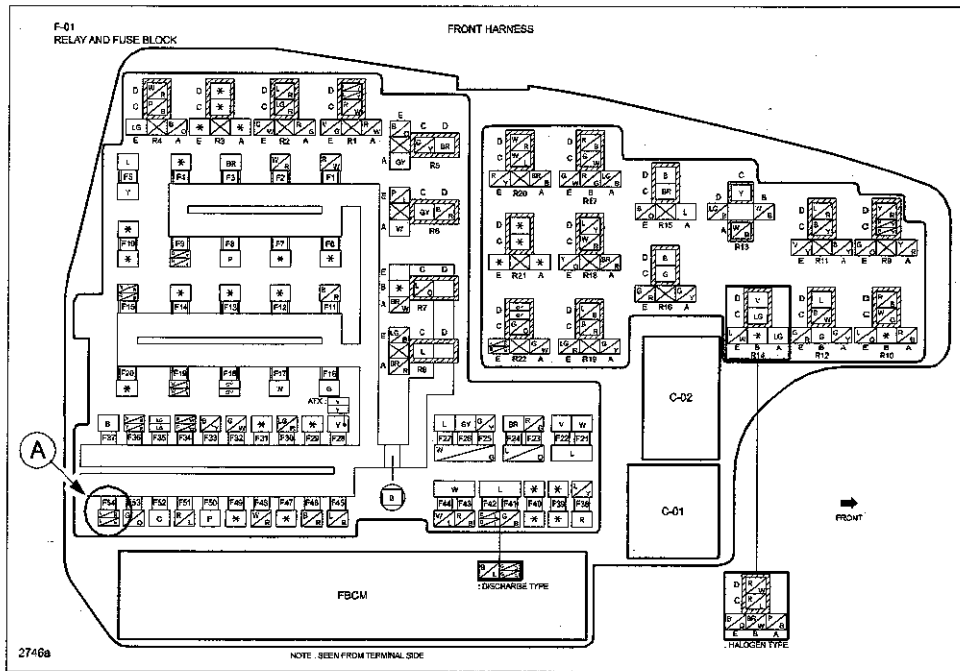
Some vehicles may experience MIL illumination with DTC P2610 (Instrument cluster internal engine off timer performance problem) stored in memory after engine start and room fuse 15A (A) removed.
