<b>Subject:</b>  <b>MIL ON WITH DTC P2610</b>	<b>Bulletin No:</b> 01-001/13
	<b>Last Issued:</b> 09/25/2013

2013-2014 CX-5

2014 Mazda6

2014 Mazda3

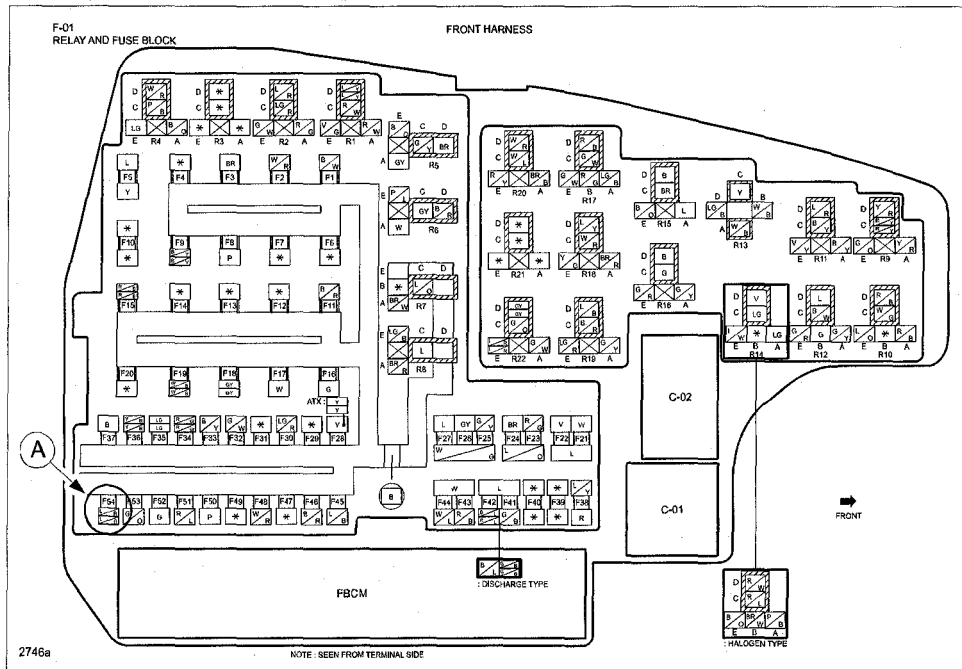
Some vehicles may experience MIL illumination with DTC P2610 (Instrument cluster internal engine off timer performance problem) stored in memory after engine start and room fuse 15A (A) removed.

1. Verify DTC P2610 is stored in PCM memory.
2. With the ignition off, install ROOM fuse 15A.
3. Clear DTC P2610 from PCM memory using IDS.
4. Verify no other DTCs are stored in memory. If so, troubleshoot them according to the MS3 online instructions or Workshop Manual.

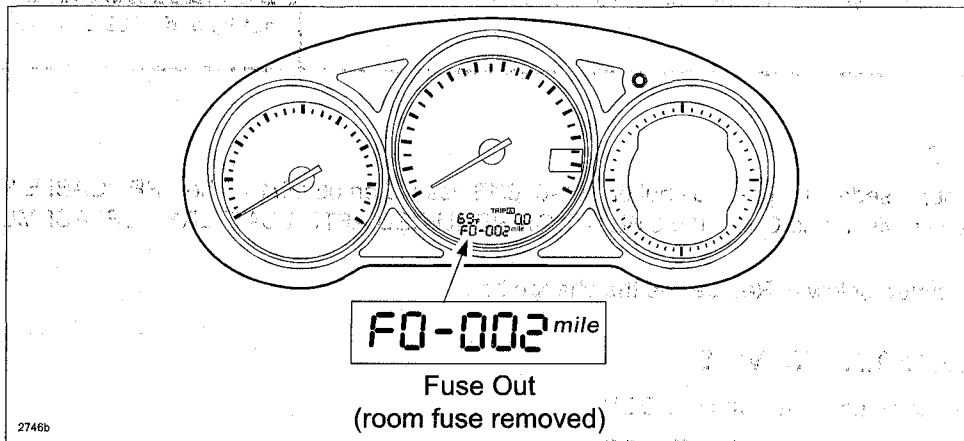
**NOTE:** The odometer will display "F0-002" during transport mode (room fuse 15A removed). Transport mode is canceled when room fuse 15A is installed or the vehicle odometer is more than 12.4mi (20km).
