Subject: 2009-2012 MAZDA6 - RATTLE NOISE AND/OR EXHAUST LEAK NOISE FROM REAR OF VEHICLE	Bulletin No: 01-002/13
	Last Issued: 01/14/2013

- This bulletin supersedes the previous bulletin 01-025/12, issued on 11/16/12. The DESCRIPTION has been revised.
- Changes are noted below in Red beside the change bar.

2009-2012 Mazda6 vehicles produced before June 7, 2012

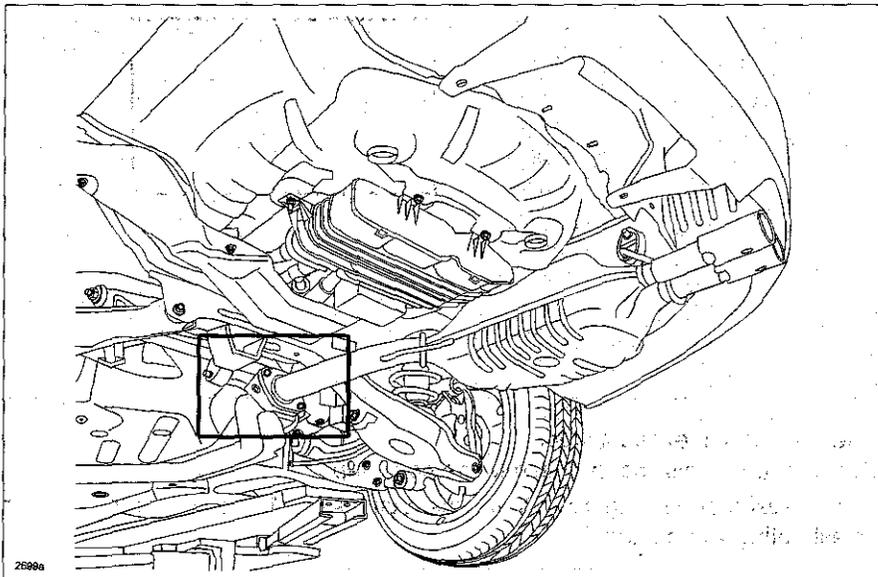
2.5L Engine:

1. Verify customer concern.
2. Safely raise vehicle on hoist.
3. Locate the exhaust joint between the main silencer and pre-silencer as shown below.

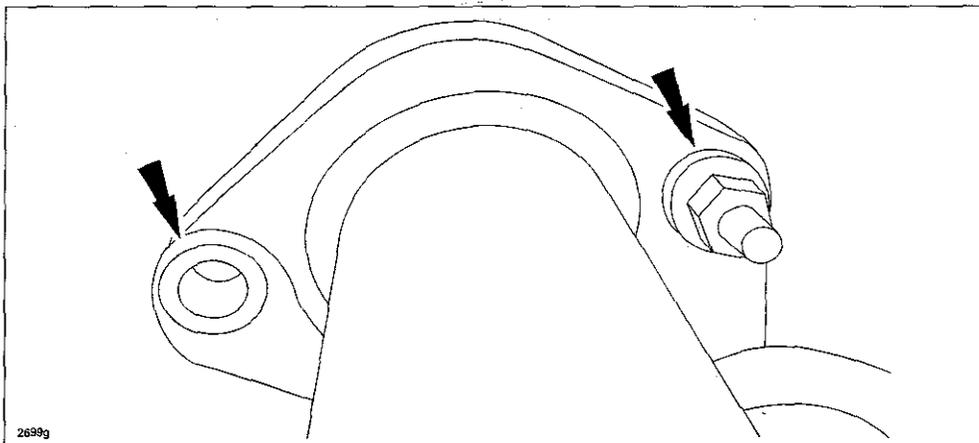
4. Inspect for broken or missing exhaust studs:

- If either stud is broken or missing, proceed to the next step.
- If neither stud is broken or missing, refer to the instructions on MS3 online or the Workshop Manual for further troubleshooting information.
