# **Service Bulletin**

ROUGH IDLE WITH MIL ON AND DTC P0015 / P0524

Bulletin No: 01-003/13

2012-2013 Mazda3 2.0L SKYACTIV 2013 CX-5

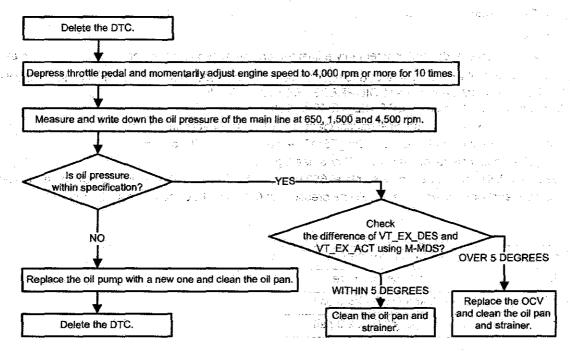
## Only P0015 is stored:

This is caused by a drop in engine oil pressure due to a piece of foreign object stuck on the oil pump pressure relief valve or OCV. The temporary entry of the foreign object triggers a MIL illumination, but rough idle will not be produced until a later time.

- 1. Delete the DTC.
- 2. Depress the throttle pedal and momentarily adjust the engine speed to 4,000 rpm or more for 10 times.
- 3. Measure the main line oil pressure at 650 rpm, 1,500 rpm and 4,500 rpm. Refer to MS3 online instructions or Workshop Manual section 01-11 OIL PRESSURE INSPECTION.
  - a. Connect M-MDS to monitor ECT, OIL-TEMP and RPM.
  - b. Start the engine and turn off all electrical loads such as A/C, headlights, etc.
  - c. Warm up the engine until ECT and OIL\_TEMP reach 90 °C (194 °F) or more.
  - d. Turn off all electrical loads such as A/C and headlights.
  - e. Wait until RPM on IDS becomes stable at 650 rpm. DO NOT read RPM on the tachometer in the vehicle.
  - f. Measure and write down the main oil line pressure at 650 rpm, 1,500 rpm and 4,500 rpm.

#### If Abnormal oil pressure is observed:

- 1) Replace the oil pump and clean the bottom of the oil pan with a clean cloth. Refer to MS3 online instructions or Workshop Manual section 01-11 OIL PUMP REMOVAL/INSTALLATION.
- 2) Replace the engine oil.

# If Normal oil pressure is observed;

- 1) Verify that the difference of VT\_EX\_DES (Exhaust valve opening angle target) and VT\_EX-ACT (Exhaust valve opening angle actual) is within 5 degrees (between 1,500 rpm and 2,000 rpm) using M-MDS.
- Within 5 degrees:
  - 1) Clean the bottom of the oil pan (with a clean cloth) and the strainer.
  - 2) Replace the engine oil.

#### Over 5 degrees;

- 1) Replace the oil control valve (OCV) with a new one.
- 1) Clean the bottom of the oil pan (with a clean cloth) and the oil strainer.
- 2) Replace the engine oil.
