<b>Subject:</b> UNUSUAL NOISE FROM EXHAUST PIPE SEAL RING	<b>Bulletin No:</b> 01-012/13
	<b>Last Issued:</b> 03/18/2013

2011-2013 Mazda2

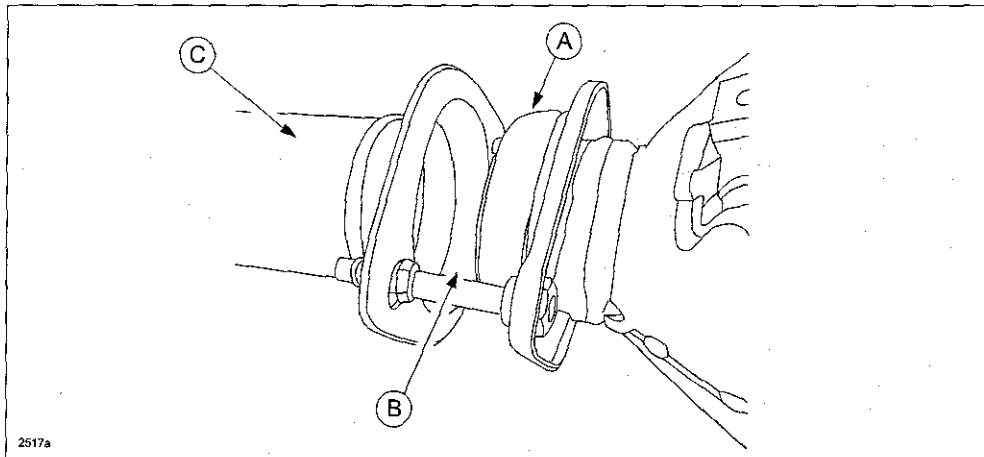
Due to engine vibration and a lack of seal ring lubrication, the mesh in the seal ring (A) rides in the flared portion (B) of the catalytic converter (C) resulting in a slight noise from the exhaust system while the engine is running. **The friction between the exhaust system parts and the resulting slight noise are normal.** This friction does not cause breakage, gas leakage, or other functional problems with the vehicle's exhaust system.

During normal vehicle aging, the noise level may change as the surface of the metal flange deteriorates. Usually this noise cannot be heard when the engine is running, however the noise may be heard in a quiet environment when the customer is outside the vehicle or when a door or window is open.

Customers having this concern should have their vehicle repaired using the following repair procedure.
