Subject: SQUEAK NOISE FROM ENGINE COMPARTMENT	Bulletin No: 01-013/13
	Last Issued: 05/28/2013

2010-2013 Mazda3 (including 2.0L SKYACTIV) **vehicles with VINs lower than JM1 BL ***** 820323 (produced before April 9, 2013)**

2012-2013 Mazda5 vehicles with VINs lower than JM1 CW *** 158910 (produced before April 9, 2013)**

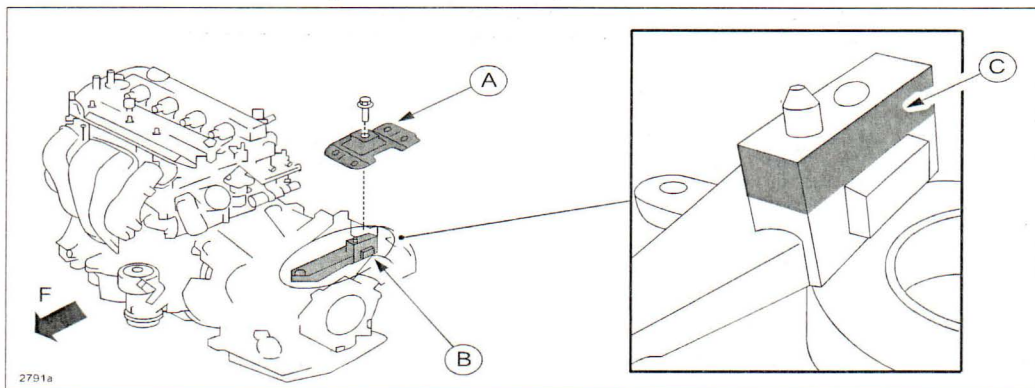
Some vehicles may exhibit a squeak noise from the engine compartment when the vehicle starts moving and/or at the time of transmission shifting. This is caused by stick-slip noise occurring at the contact surfaces between the No. 4 engine mount rubber and the No. 4 engine mount bracket when the engine shakes back and forth.

1. Verify customer concern.
2. Remove the No. 4 engine mount rubber (A) from the No. 4 engine mount bracket (B). Refer to MS3 online instructions or Workshop Manual:
 - Mazda3 SKYACTIV - (section 01-10 ENGINE REMOVAL/INSTALLATION [SKYACTIV-G 2.0]).
 - Mazda3 MZR 2.0, 2.5 - (section 01-10 ENGINE REMOVAL/INSTALLATION [MZR 2.0, MZR 2.5]).
 - **Mazda5 - (section 01-10 ENGINE REMOVAL/INSTALLATION [MZR 2.5]).**
3. Clean the surfaces of the No. 4 engine mount bracket (C) where it contacts the mount rubber.
