Subject: MAZDA RADAR CRUISE CONTROL (MRCC) WARNING LIGHT ON WITH DTC C1A67:92	Bulletin No: 01-014/13
	Last Issued: 06/14/2013

2014 Mazda6 vehicles with VINs from JM1 GJ ***** 103113 to JM1 GJ ***** 112154 (produced from December 3, 2012 to February 21, 2013)

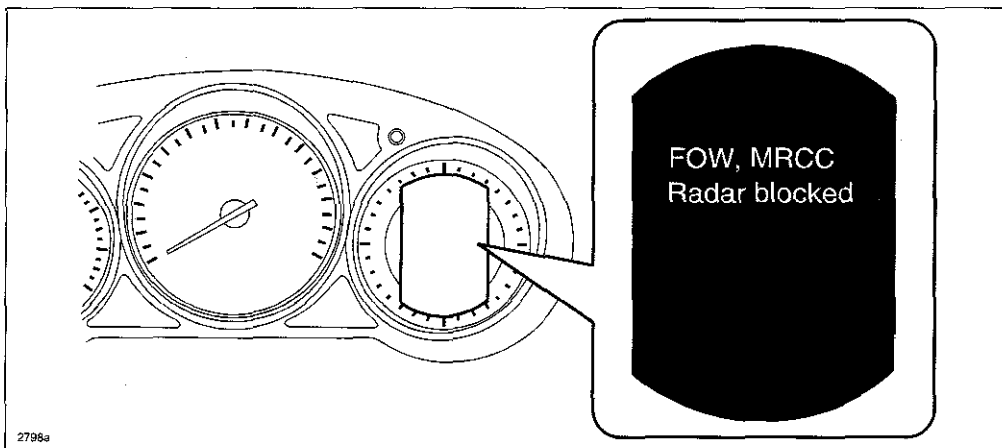
Some vehicles may experience a Mazda Radar Cruise Control (MRCC) warning light on with DTC C1A67:92 (Radar sensor sensitivity lowered). FOW, MRCC Radar blocked message will be displayed in the Instrument Cluster Multi-Information Display.
